APPENDIX E

GEOTECHNICAL CONSIDERATIONS

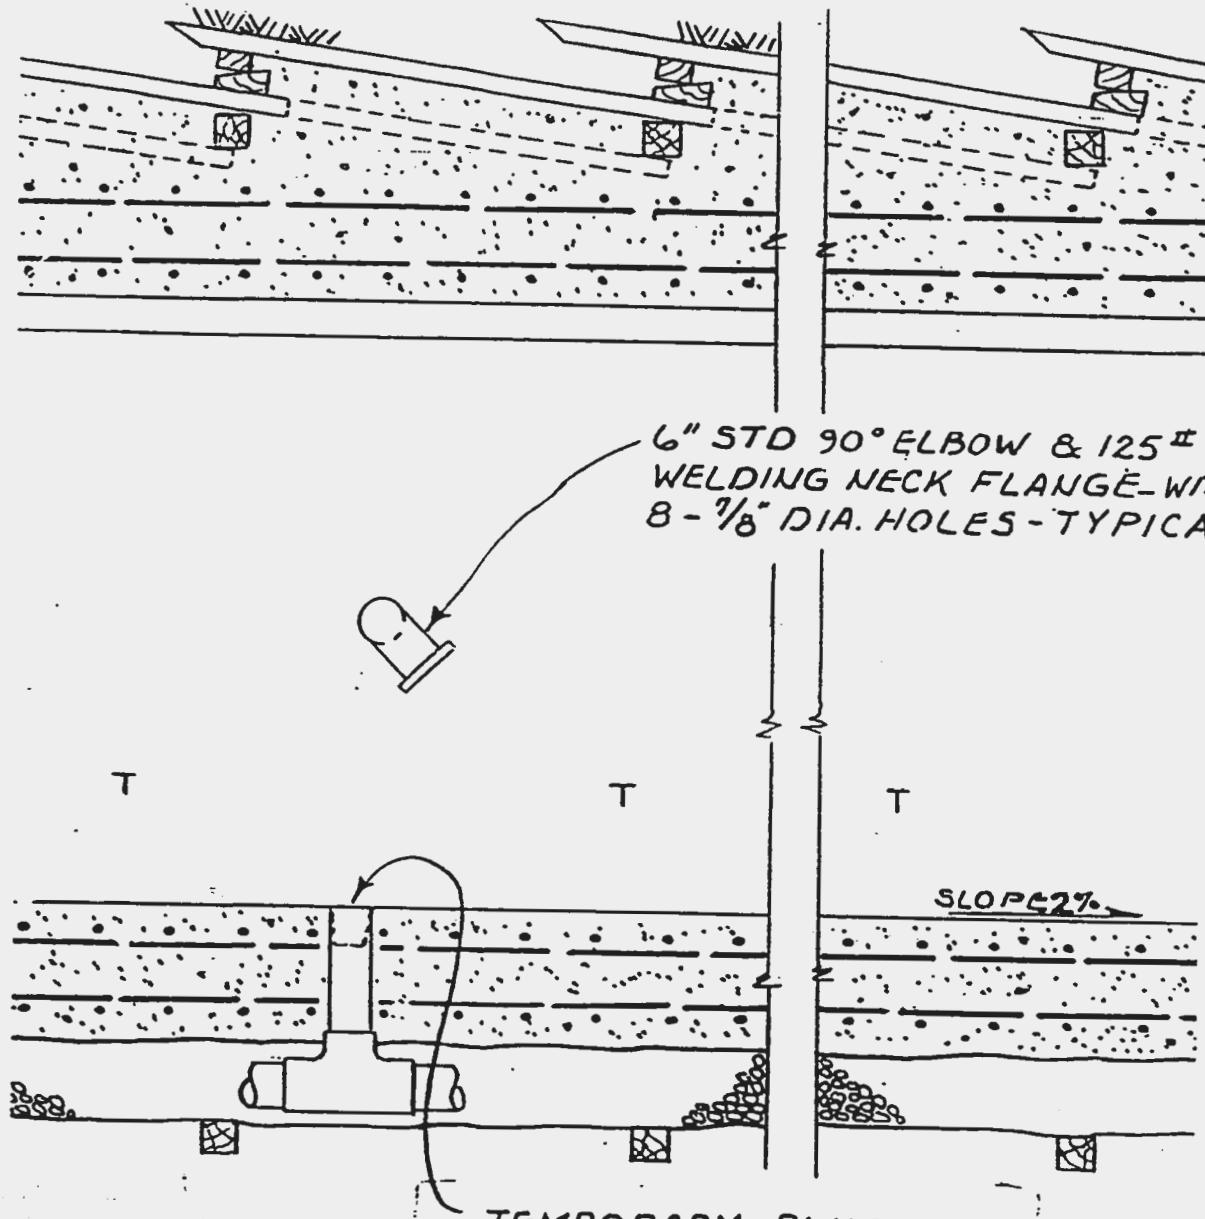
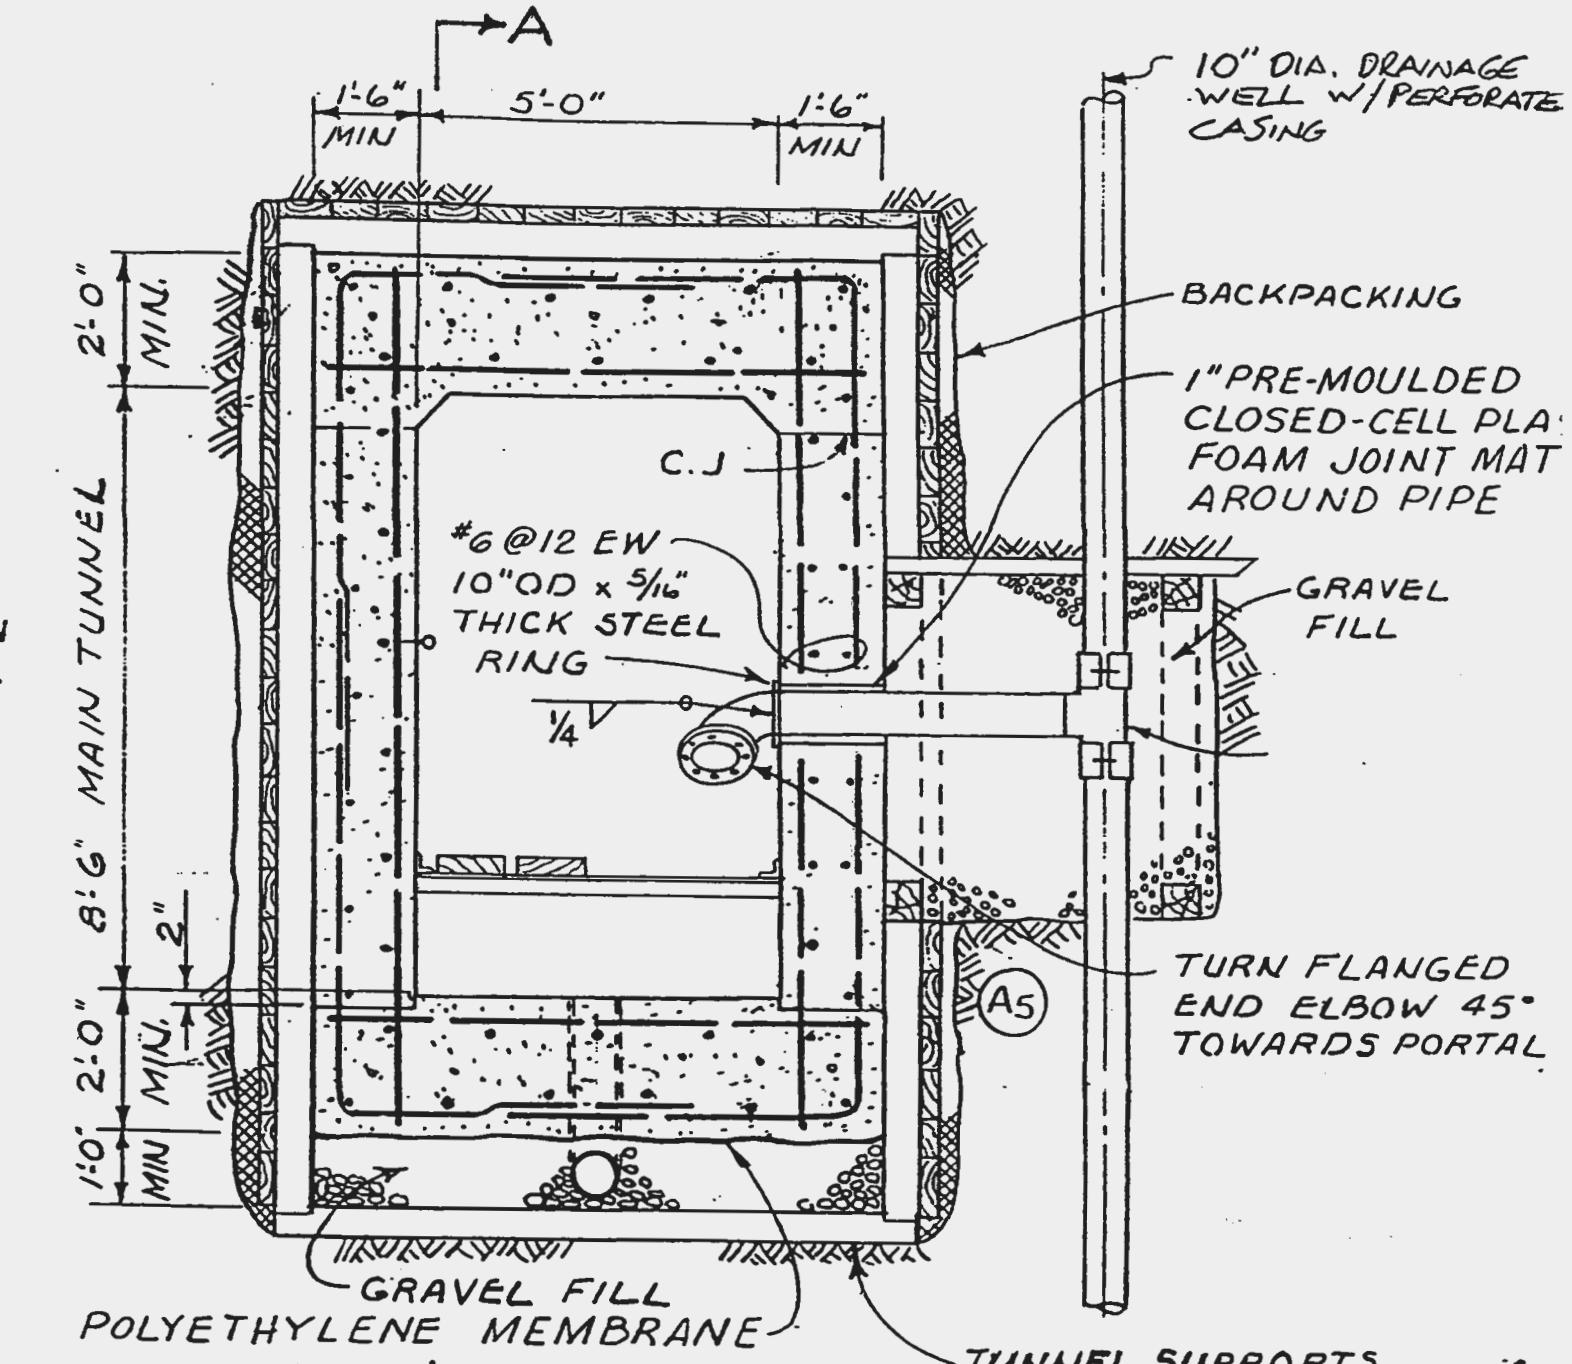
TYPICAL TUNNEL SECTION
(REFERENCE - AS BUILT DRAWING
FOR EXISTING TUNNEL - E-56-11-53)

Work PLATFORM

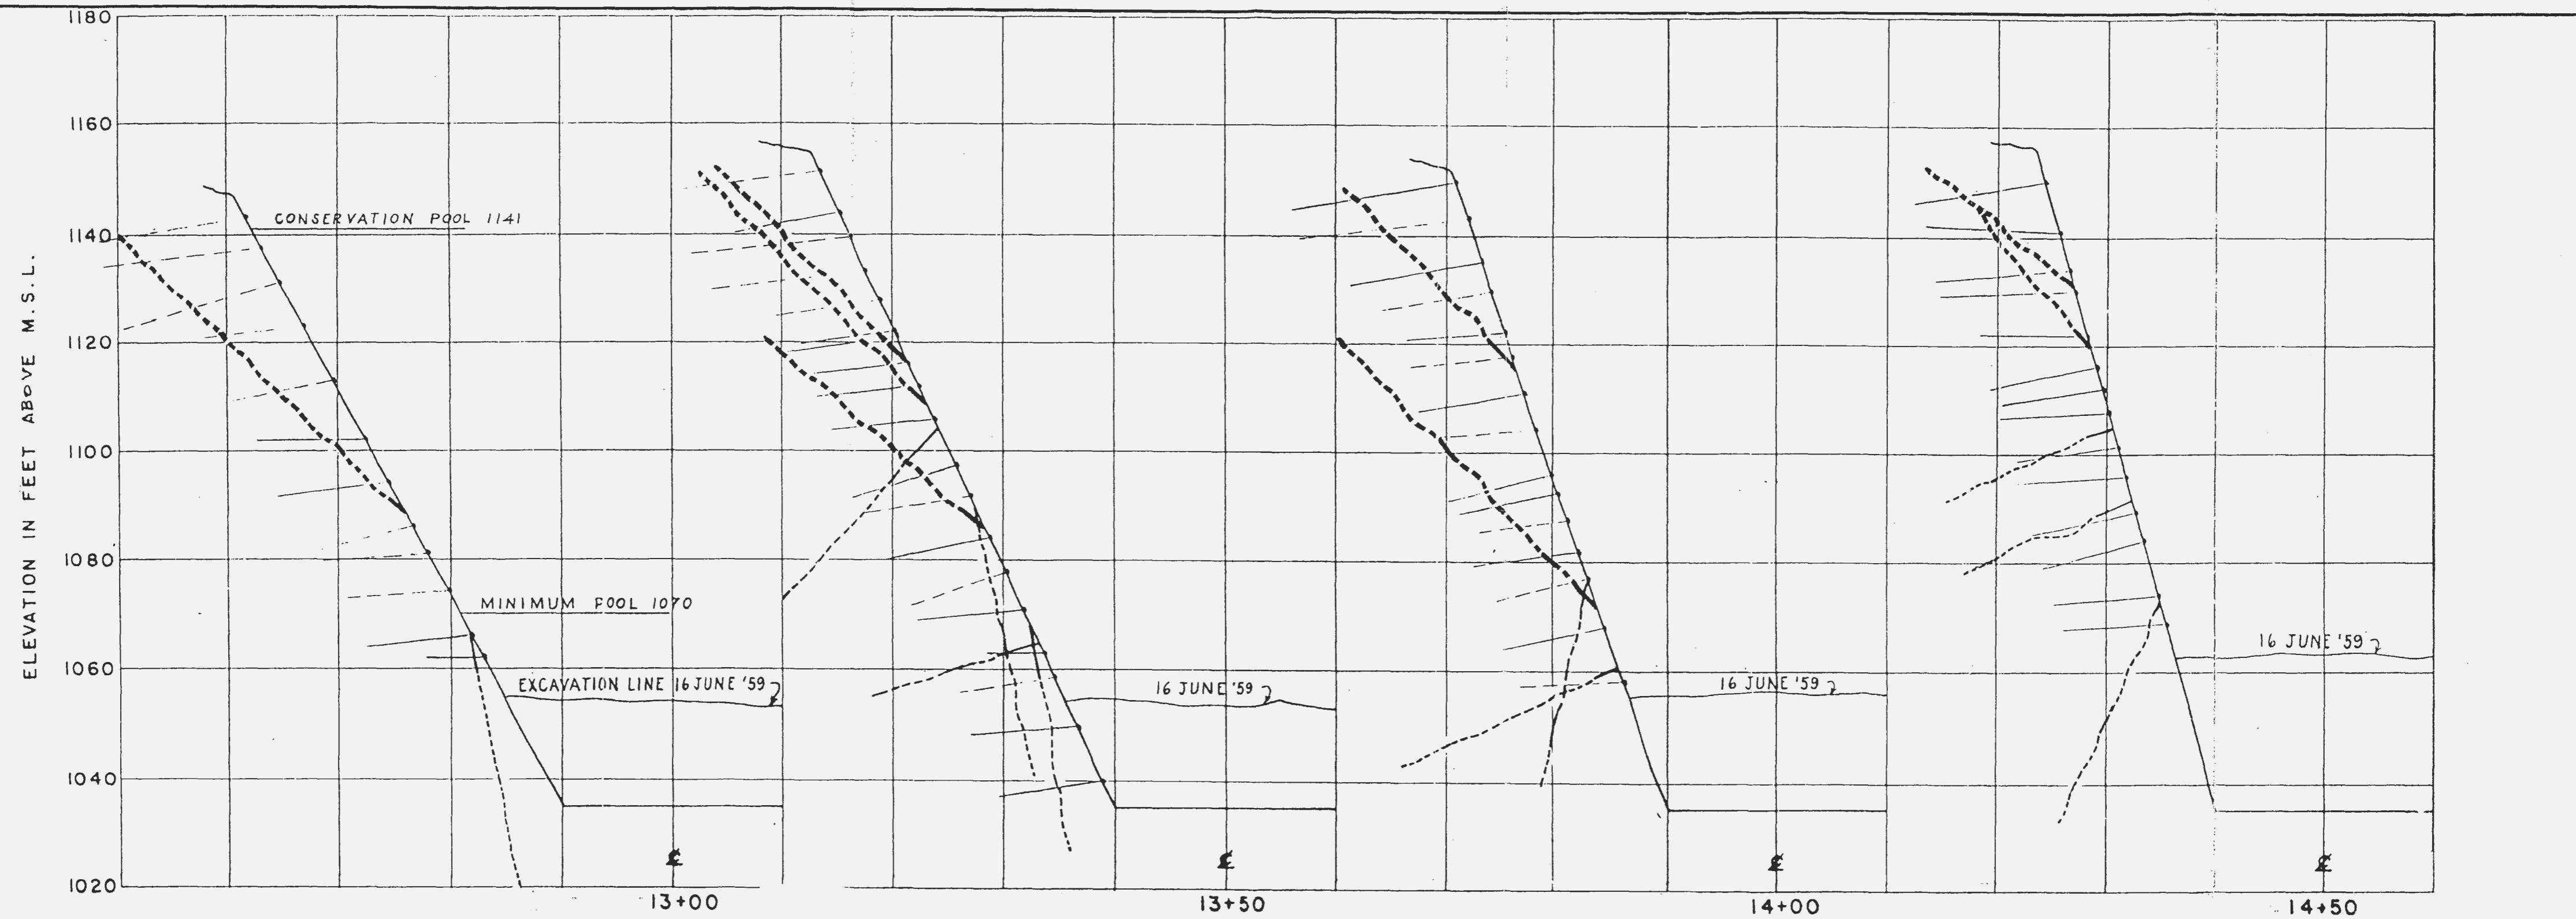
PLATE E-13

U. S. ARMY ENGINEER DISTRICT, SEATTLE CORPS OF ENGINEERS SEATTLE, WASHINGTON		
MAJOR JOINTS ON LEFT ROCKWALL OF EXISTING INTAKE CHANNEL		
HOWARD HANSON DAM		WASHINGTON
SIZE	INVITATION NO.	FILE NO.
B		
DESIGN: ECKERLIN		CHK: MANN
SHEET

1. The potential slippage surfaces shown on the plan and sections are overemphasized for purposes of illustration. These surfaces, however, can be located by careful observation of the excavation.
2. Joints and faults are not differentiated.
3. Joints are shown in approximate position and attitude of joints is estimated from bottom of excavation.
4. The numerous minor fractures and joints are not shown.
5. Rock bolts are placed on about five (5) foot centers. The bolts in the upper 20 feet of the face are 30 feet long and the lower portion of the face is secured by rock bolts 20 feet long.

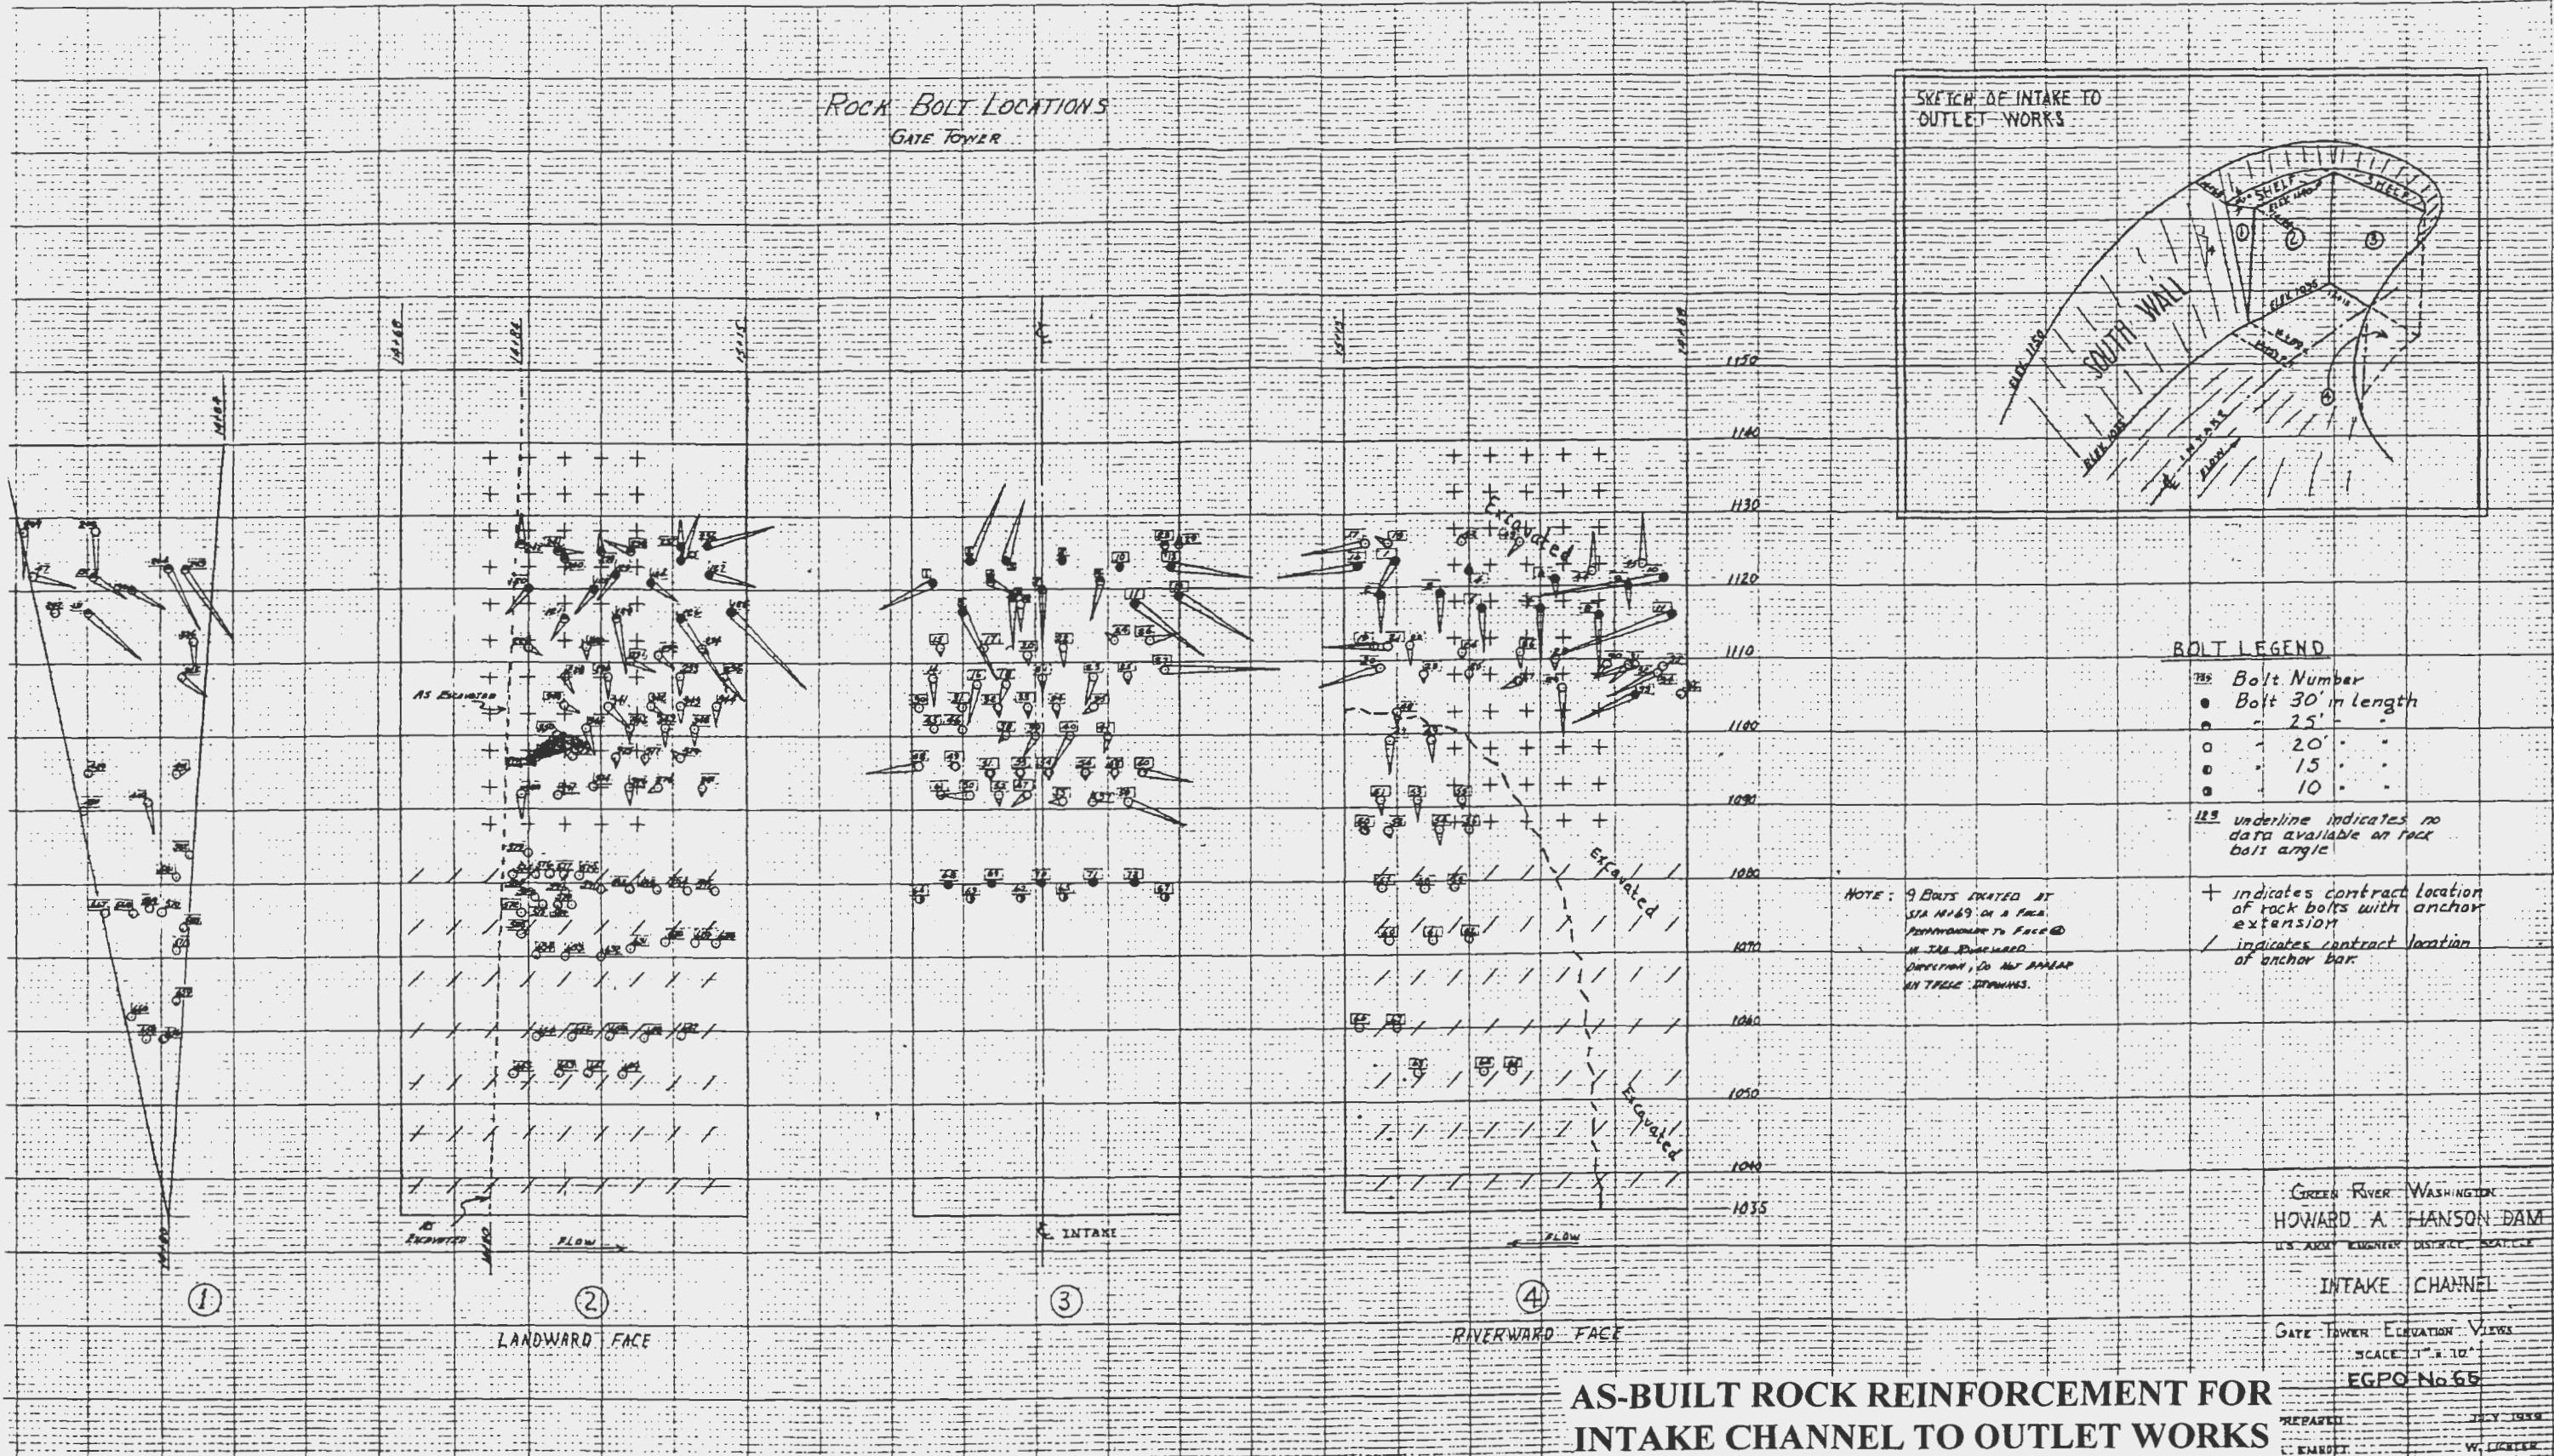
Rock Bolt Locations

INTAKE CHANNEL WALL

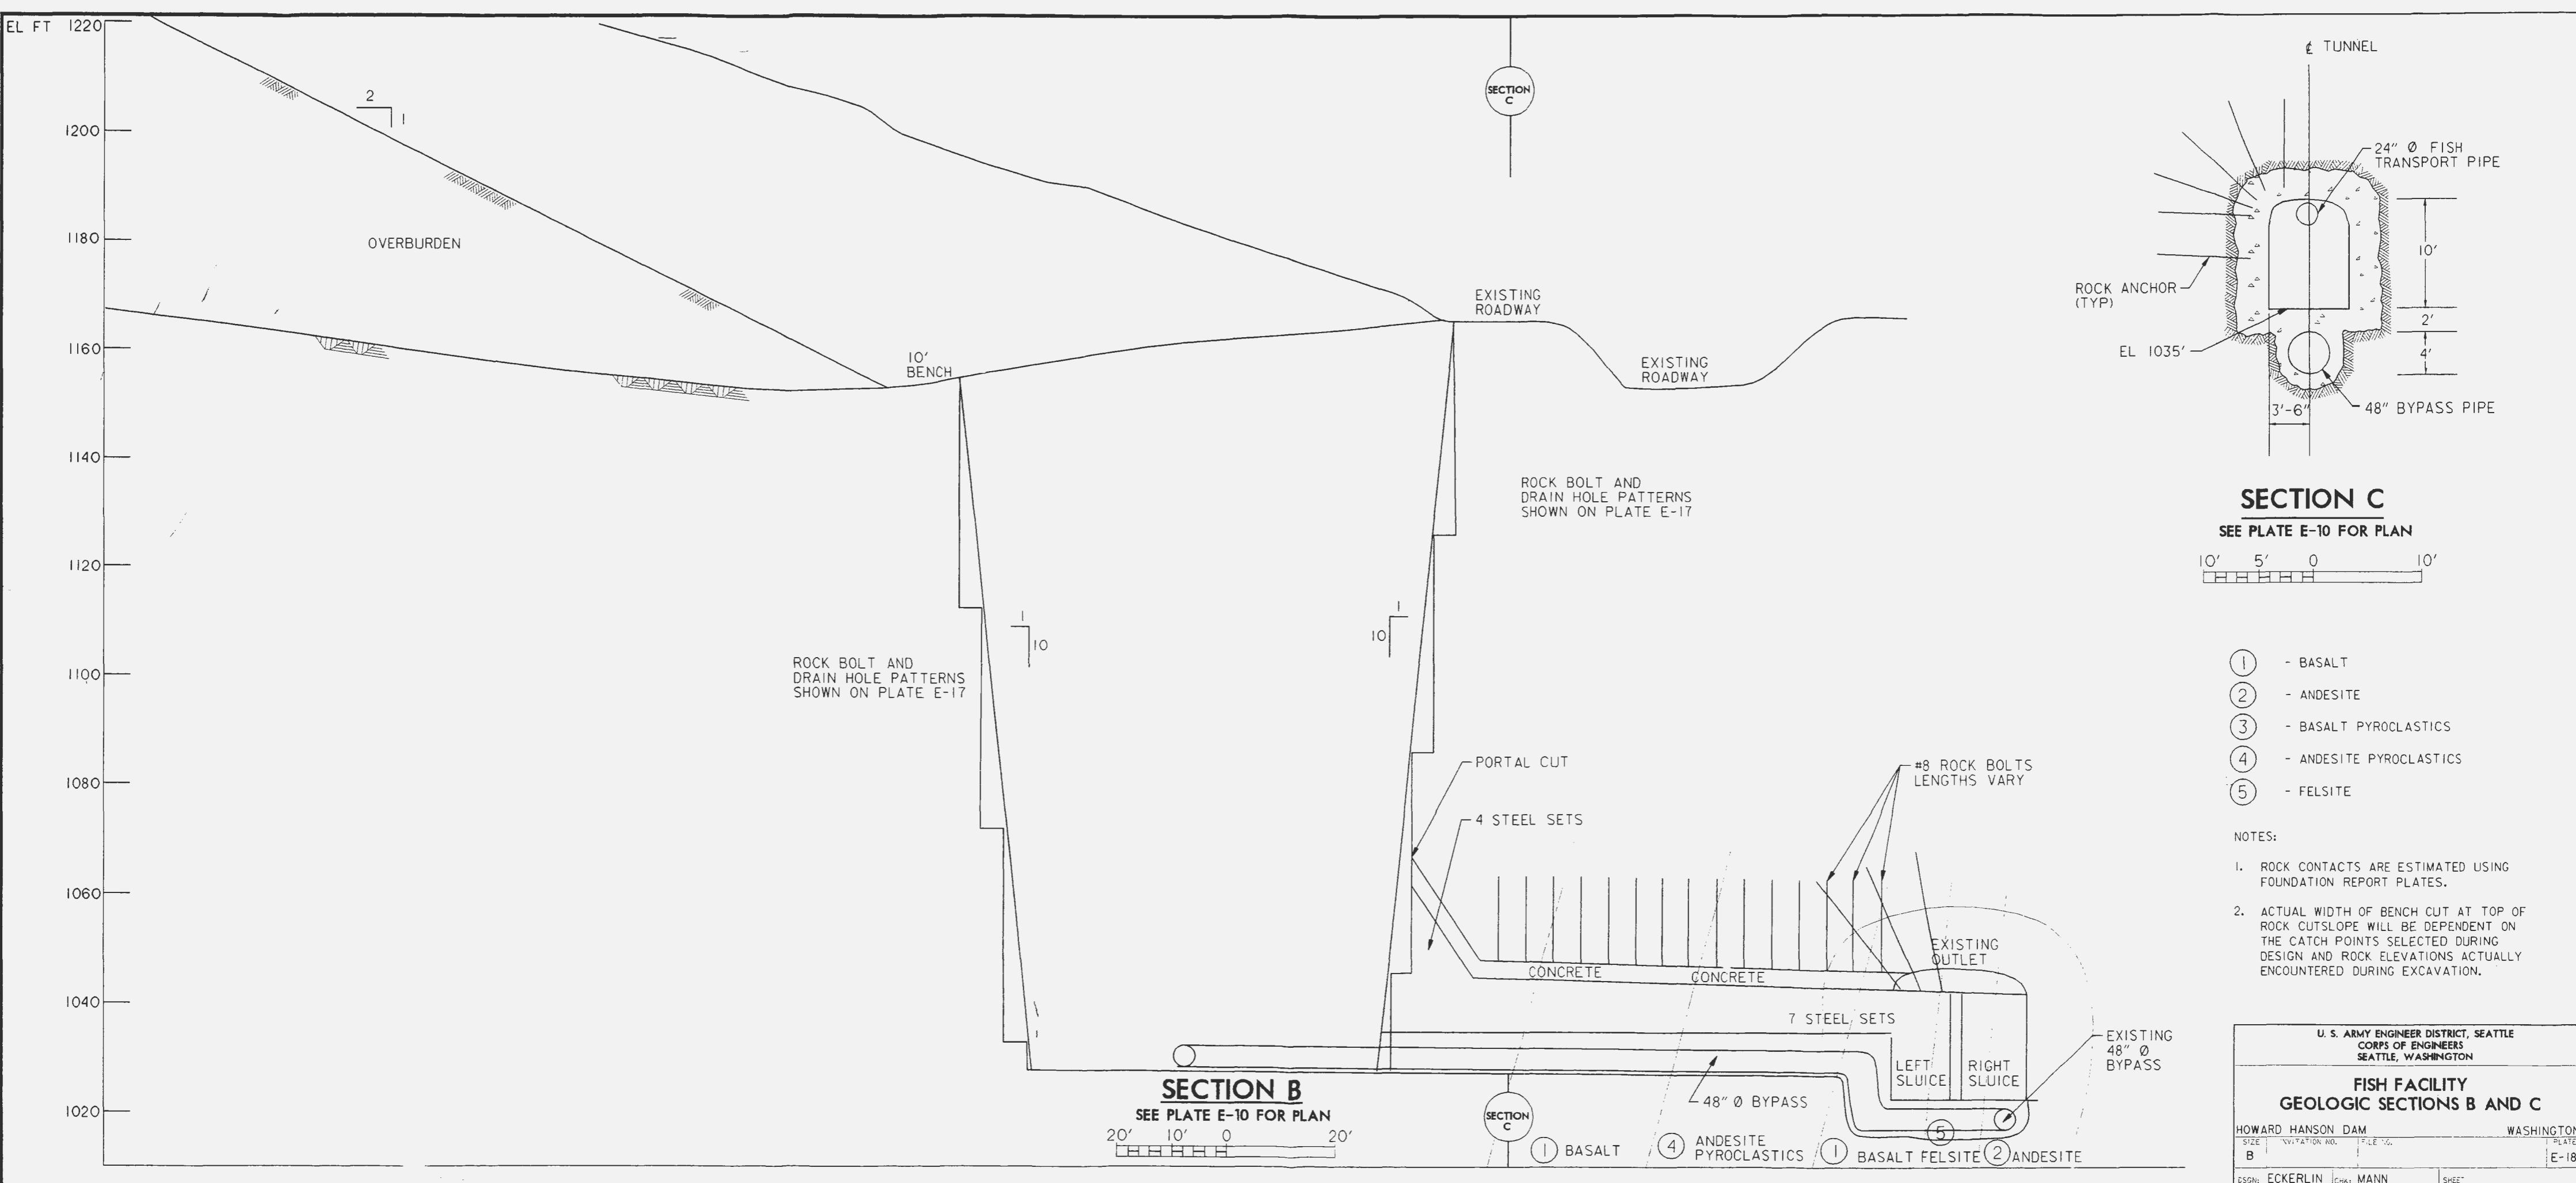
PLATE B-18

U. S. ARMY ENGINEER DISTRICT, SEATTLE
CORPS OF ENGINEERS
SEATTLE, WASHINGTON
FISH FACILITY
GEOLOGIC SECTIONS B AND C
HOWARD HANSON DAM WASHINGTON
SIZE INVITATION NO. FILE NO. PLATE
B ECKERLIN CHK: MANN E-18
DSGN: ECKERLIN CHK: MANN SHEET

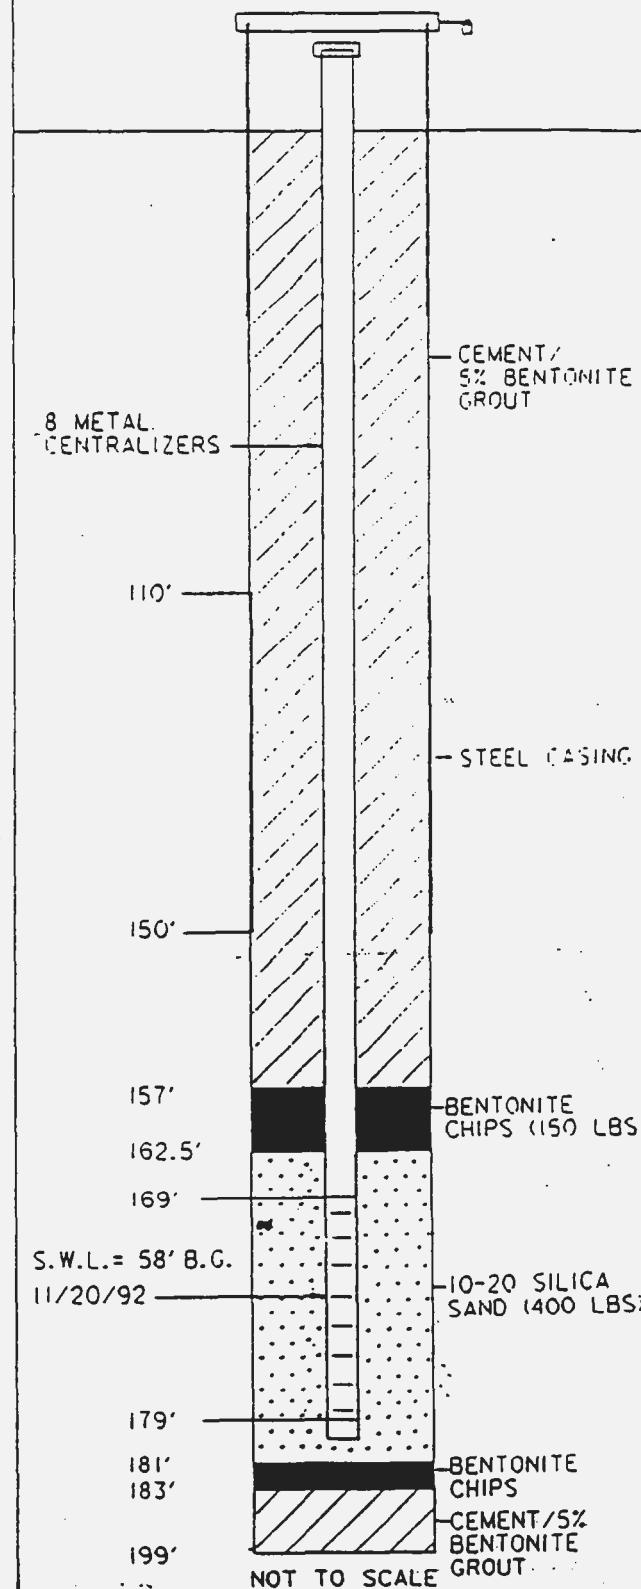
WELL DETAIL (AS BUILT) 92-RD-110 NOT TO SCALE

REMARKS: 40 FEET OF CASING (WITH DRIVE SHOE) LEFT IN HOLE FROM 110 FEET TO 150 FEET. ALL OTHER CASING REMOVED FROM HOLE.

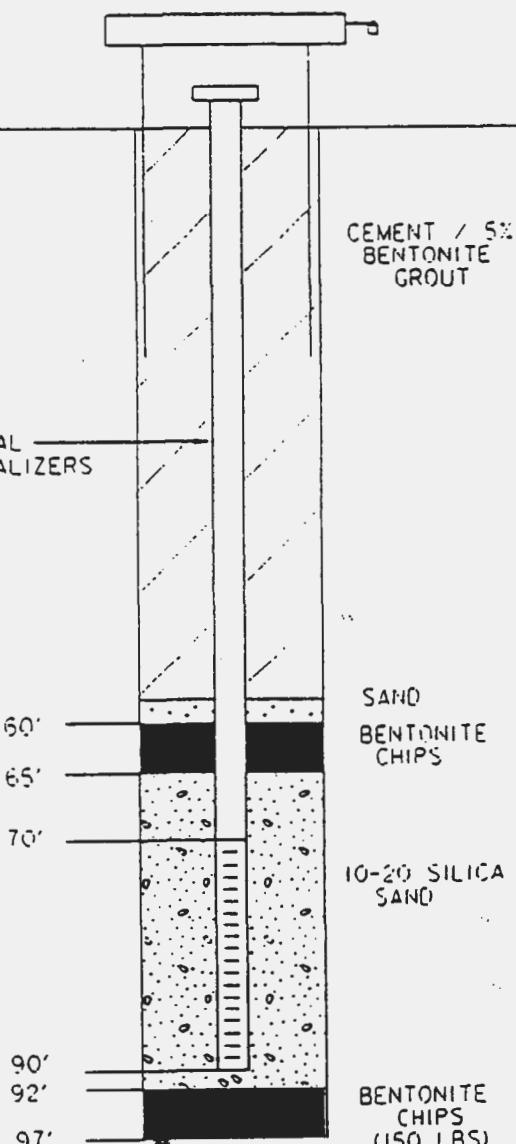
WELL DETAIL (AS BUILT)
92-RD-113
NOT TO SCALE

REMARKS: GROUT LOSS @ 30' STOPPED BY
ADDING SAND AND BENTONITE CHIPS TO GROUT

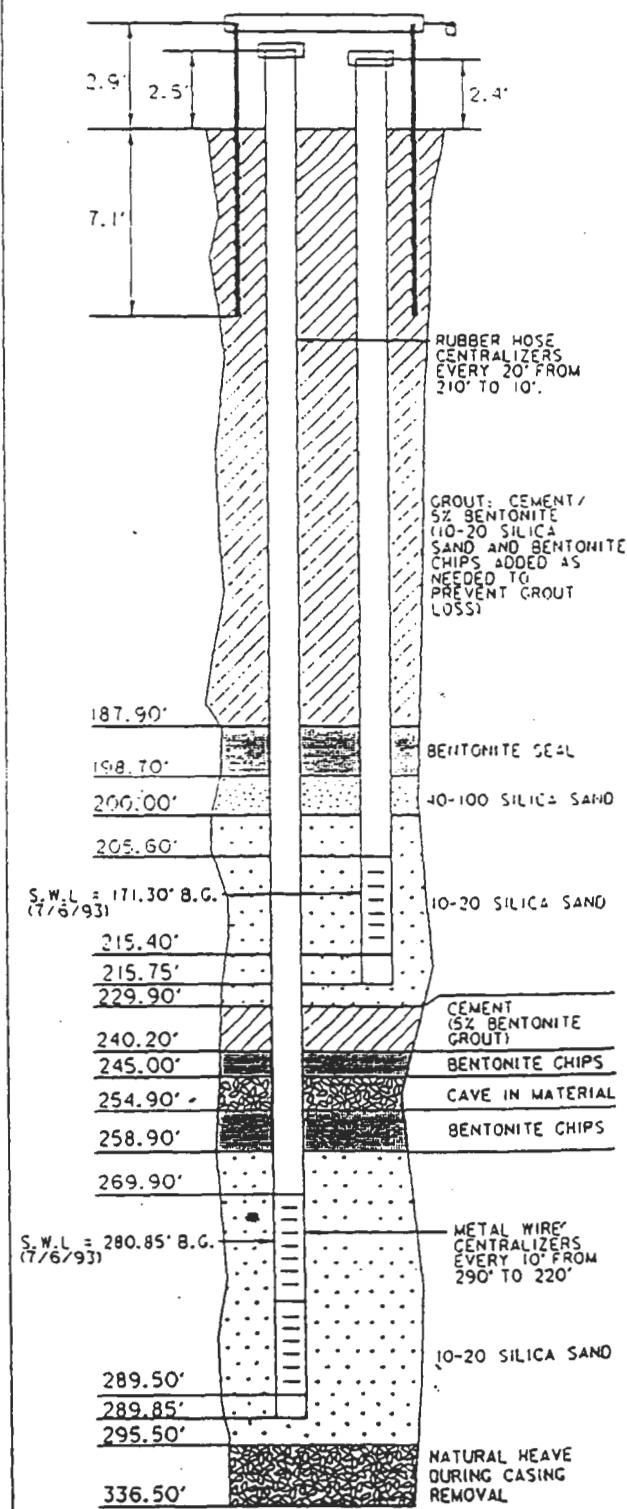
WELL DETAIL (AS BUILT) 93-RD-114 NOT TO SCALE

REMARKS: PULLING CASING WAS VERY DIFFICULT
AND COULD NOT ADD GROUT AT BOTTOM UNTIL
CASING PULLED, BUT FORMATION COLLAPSED INTO
THE HOLE AS FAST AS CASING WAS REMOVED.
270' OF WIRE LOST IN HOLE AT 257' AND WIRE
BUNCHED AROUND STABILIZER AT 220'. 281.5' OF
WIRE AND 1.5' OF REBAR LOST IN HOLE AT 271' B.G.

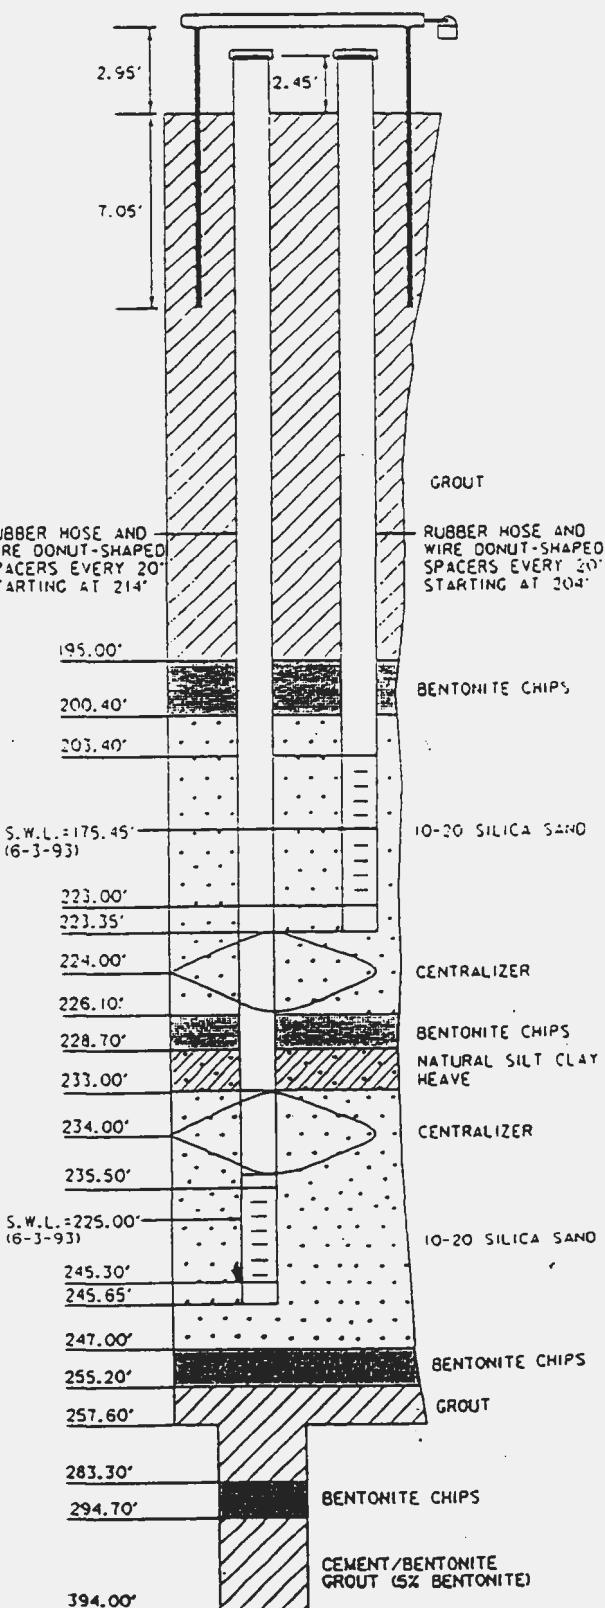
WELL DETAIL (AS BUILT) 93-RD-115 NOT TO SCALE

STOPPED BY ADDING SAND AND BENTONITE CHIPS.

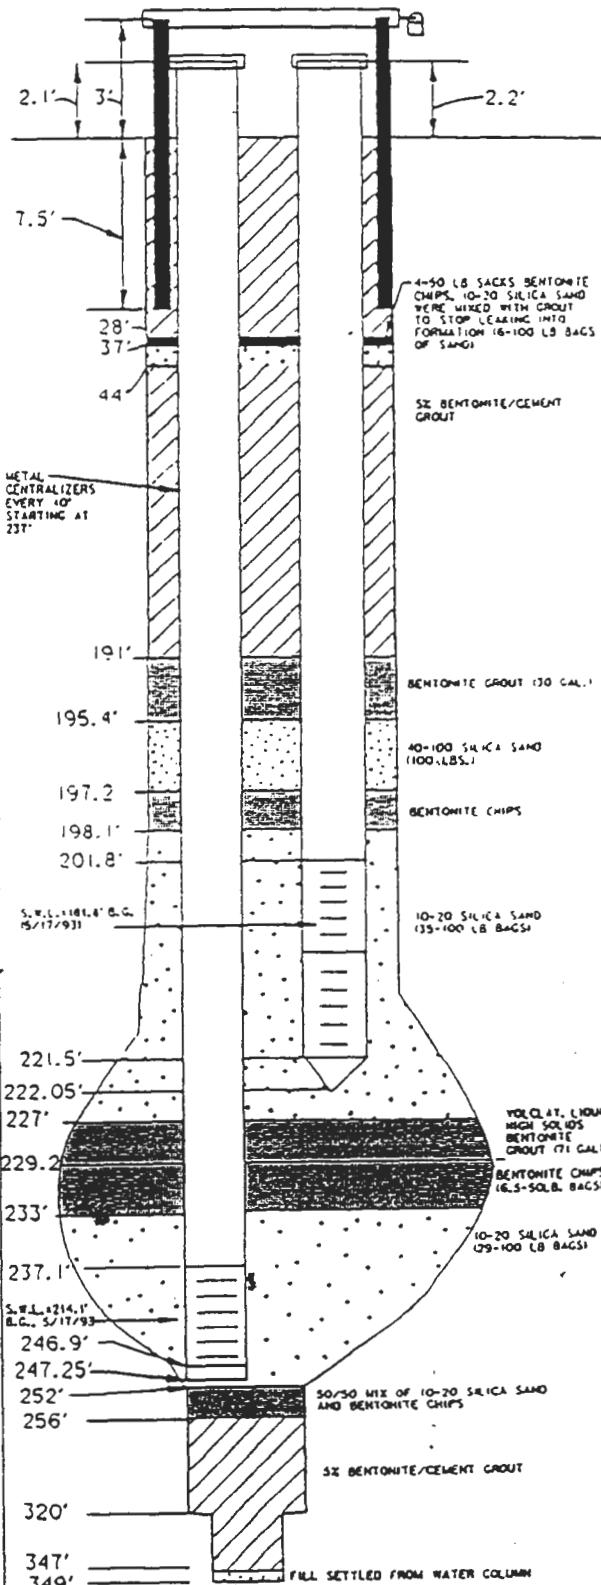
REMARKS: ALL STEEL CASING REMOVED DURING WELL COMPLETION. LARGE CAVITY SUSPECTED AROUND LOWER SCREEN FROM CASING REMOVAL AND SUBSEQUENT REDRILLING (SEE DRILLING LOG). CENTRALIZERS INSTALLED ON LOWER STAGE EVERY 40' BEGINNING AT 197'. 10.5' OF STEEL CASING ADDED DURING SURFACE COMPLETION AS WELL PROTECTION.

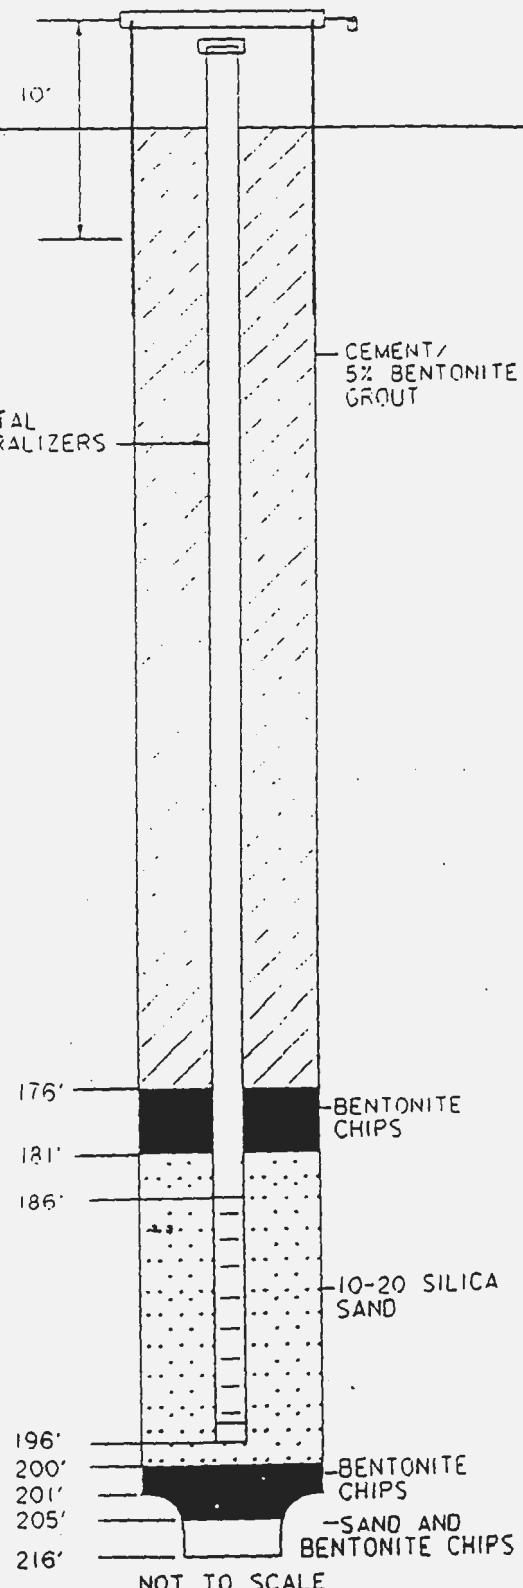
92-RD-118
NOT TO SCALE

WELL DETAIL (AS BUILT)

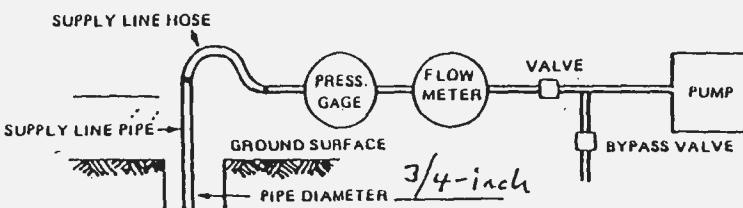
TYPICAL EQUIPMENT SKETCH

NOTES (1) Use comments space if changes occur in the static water level during testing.

(4) Cont. - the supply line diameter or length, or packer is changed. This data will be used later in the office to calculate supply line pressure.

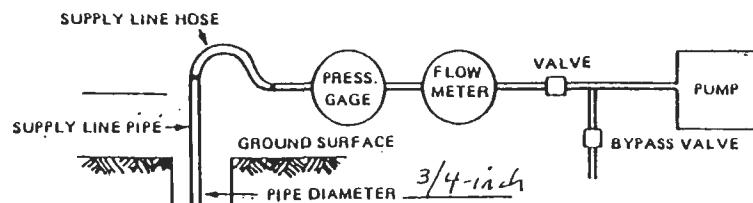
TYPICAL EQUIPMENT SKETCH

NOTES (1) Use comments space if changes occur in the static water level during testing.

(2) Test each interval at two different gage pressures.

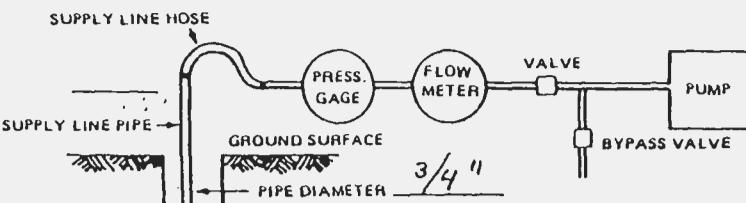
TYPICAL EQUIPMENT SKETCH

- NOTES
- (1) Use comments space if changes occur in the static water level during testing.
 - (2) Test each interval at two different gage pressures.
 - (3) Give accumulative total length of supply line pipe exclusive of supply line hose and packer assy.
 - (4) Connect packer to supply line hose on horiz. surface. Record gage pressure for flow in 5g. p.m. increments to 30 g.p.m. on back of this form. Repeat each time
 - (4) Cont. - the supply line diameter or length, or packer is changed. This data will be used later in the office to calculate supply line pressure.
 - (5) Gallon = $ft^3 + 7.48 = liter \times 3.79$
 - (6) Column Pressure (P.S.I.) = Vertical dist. from gage to the smaller of packer or static water level $\times (0.433 P.S.I./ft)$
 - (7) Net Pressure (P.S.I.) = Gage Press. + Column Press. - Supply Line Press (This is the actual internal pressure)

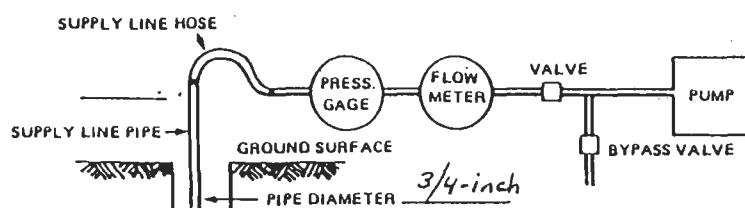
TYPICAL EQUIPMENT SKETCH

- (1) Use comments space if changes occur in the static water level during testing.
 - (2) Test each interval at two different gage pressures.
 - (3) Give accumulative total length of supply line pipe exclusive of supply line hose and packer assy.
 - (4) Connect packer to supply line hose on horiz. surface. Record gage pressure for flow in $\frac{g}{min}$ increments to 30 g.p.m. on back of this form. Repeat each time
 - (4) Cont. - the supply line diameter or length, or packer is changed. This data will be used later in the office to calculate supply line pressure.
 - (5) Gallon = $l^3 + 7.48 = \text{liter} \times 3.79$
 - (6) Column Pressure (P.S.I.) = Vertical dist. from gage to the smaller of packer or static water level x (0.433 P.S.I./ft)
 - (7) Net Pressure (P.S.I.) = Gage Press. + Column Press. -- Supply Line Press. (This is the actual internal pressure)

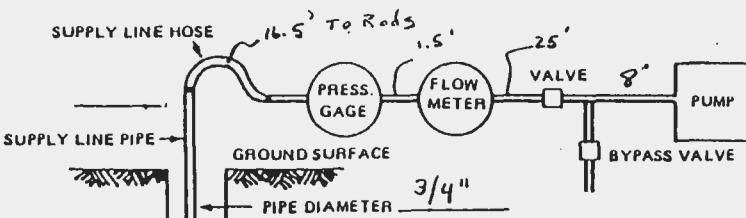
TYPICAL EQUIPMENT SKETCH

- NOTES
- (1) Use comments space if changes occur in the static water level during testing.
 - (4) Cont. - the supply line diameter or length, or packer is changed. This data will be used later in the office to calculate supply line pressure.
 - (5) Gallon = $l^3 + 7.48 - \text{liter} \times 3.79$
 - (6) Column Pressure (P.S.I.) = Vertical dist. from gage to the smaller of packer or static water level $\times (0.433 \text{ P.S.I./ft})$
 - (7) Net Pressure (P.S.I.) = Gage Press. + Column Press. - Supply Line Press. (This is the actual internal pressure.)
 - (2) Test each interval at two different gage pressures.
 - (3) Give accumulative total length of supply line pipe exclusive of supply line hose and packer assy.
 - (4) Connect packer to supply line hose on horiz. surface. Record gage pressure for flow in Sg. p.m. increments to 30 g.p.m. on back of this form. Repeat each time

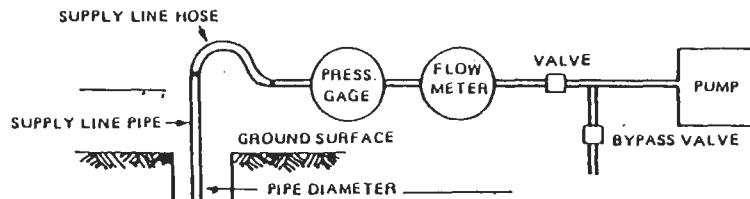
TYPICAL EQUIPMENT SKETCH

- NOTES
- (1) Use comments space if changes occur in the static water level during testing.
 - (2) Test each interval at two different gage pressures.
 - (3) Give accumulative total length of supply line pipe exclusive of supply line hose and packer assy.
 - (4) Connect packer to supply line hose on horiz. surface. Record gage pressure for flow in Sg. p.m. increments to 30 g.p.m. on back of this form. Repeat each time
 - (4) Cont. - the supply line diameter or length, or packer is changed. This data will be used later in the office to calculate supply line pressure.
 - (5) Gallon - $ft^3 \div 7.48 = liter \times 3.79$
 - (6) Column Pressure (P.S.I.) = Vertical dist. from gage to the smaller of packer or static water level $\times 0.433$ P.S.I./ft
 - (7) Net Pressure (P.S.I.) = Gage Press. + Column Press. - Supply Line Press. (This is the actual internal pressure.)

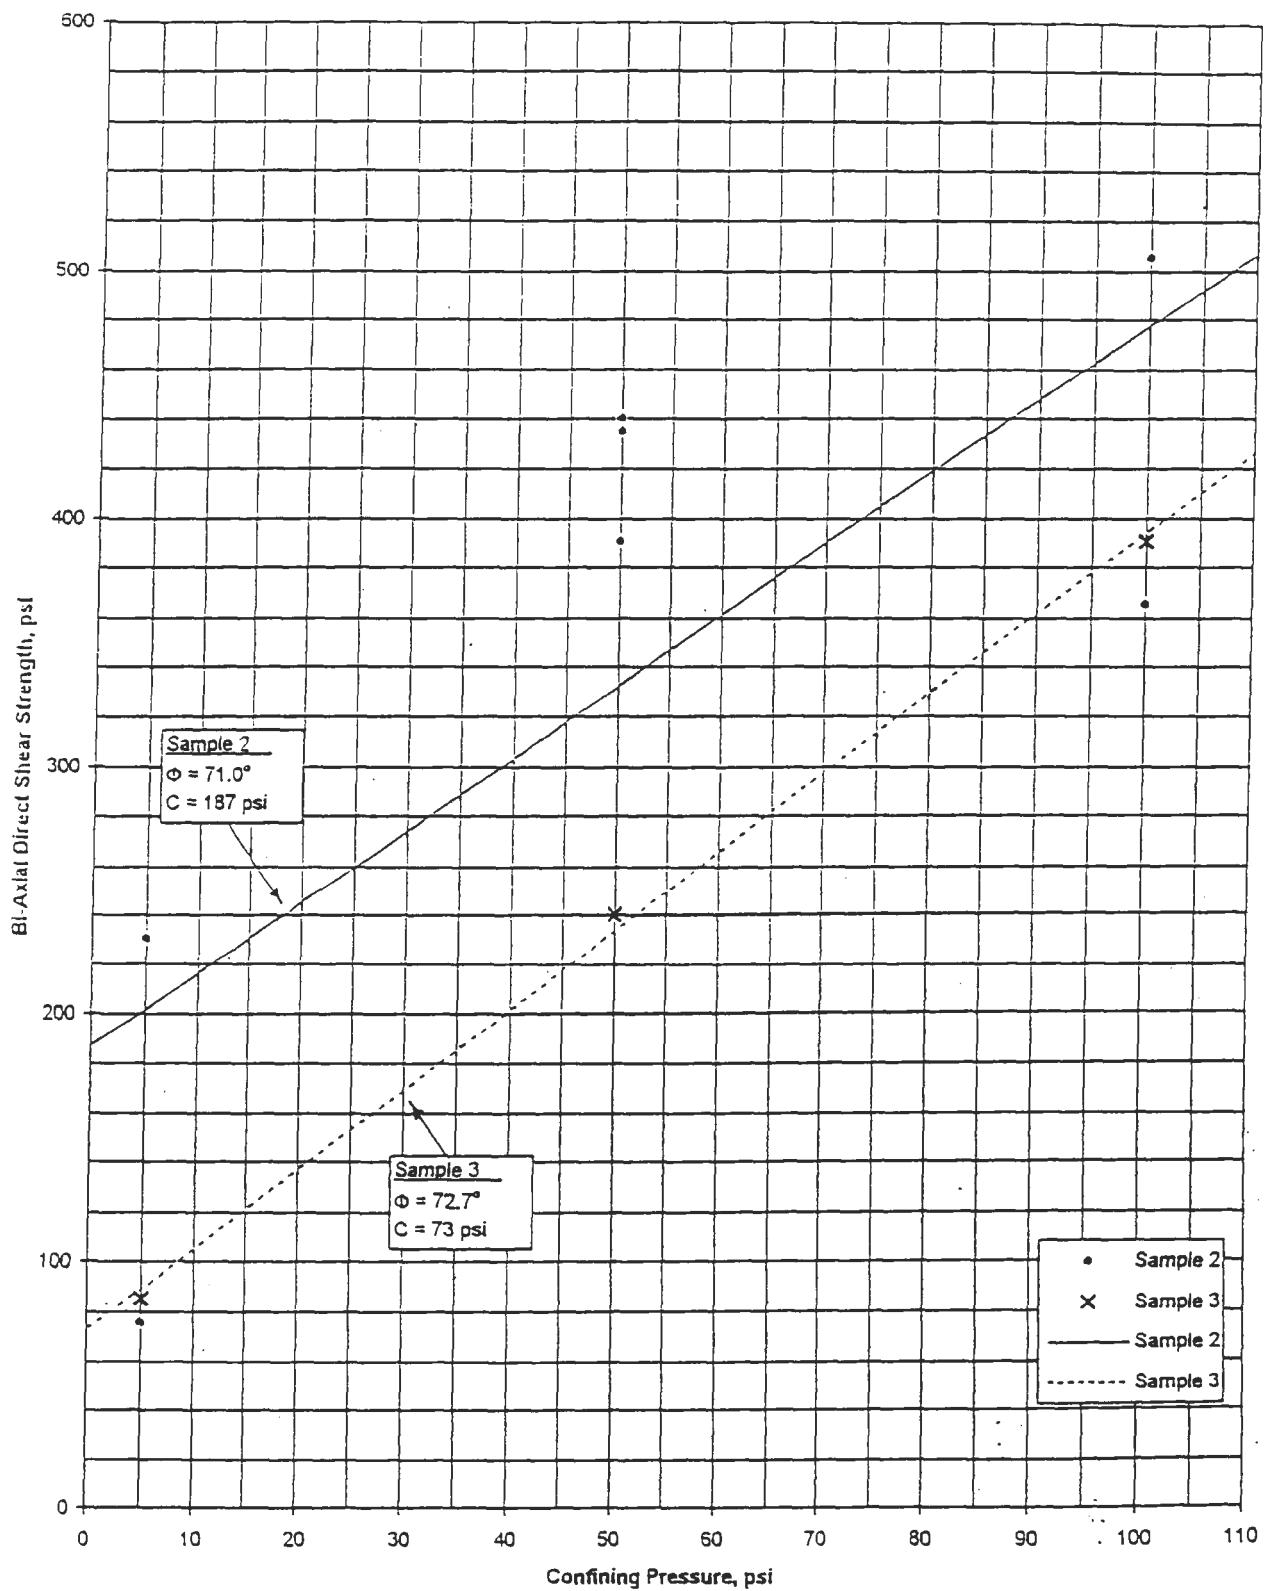
Howard Hanson Dam Fish Facility Feasibility Study
Figure I
Bi-Axial Direct Shear Strength versus Confining Pressure,
Sawn Rock-Grout Joints

d) Enclosure 4, Figure 1, Graphical Report of Bi-Axial Direct Shear Strength Tests on Sawn Rock-Grouted Joints.
