APPENDIX E

GEOTECHNICAL CONSIDERATIONS

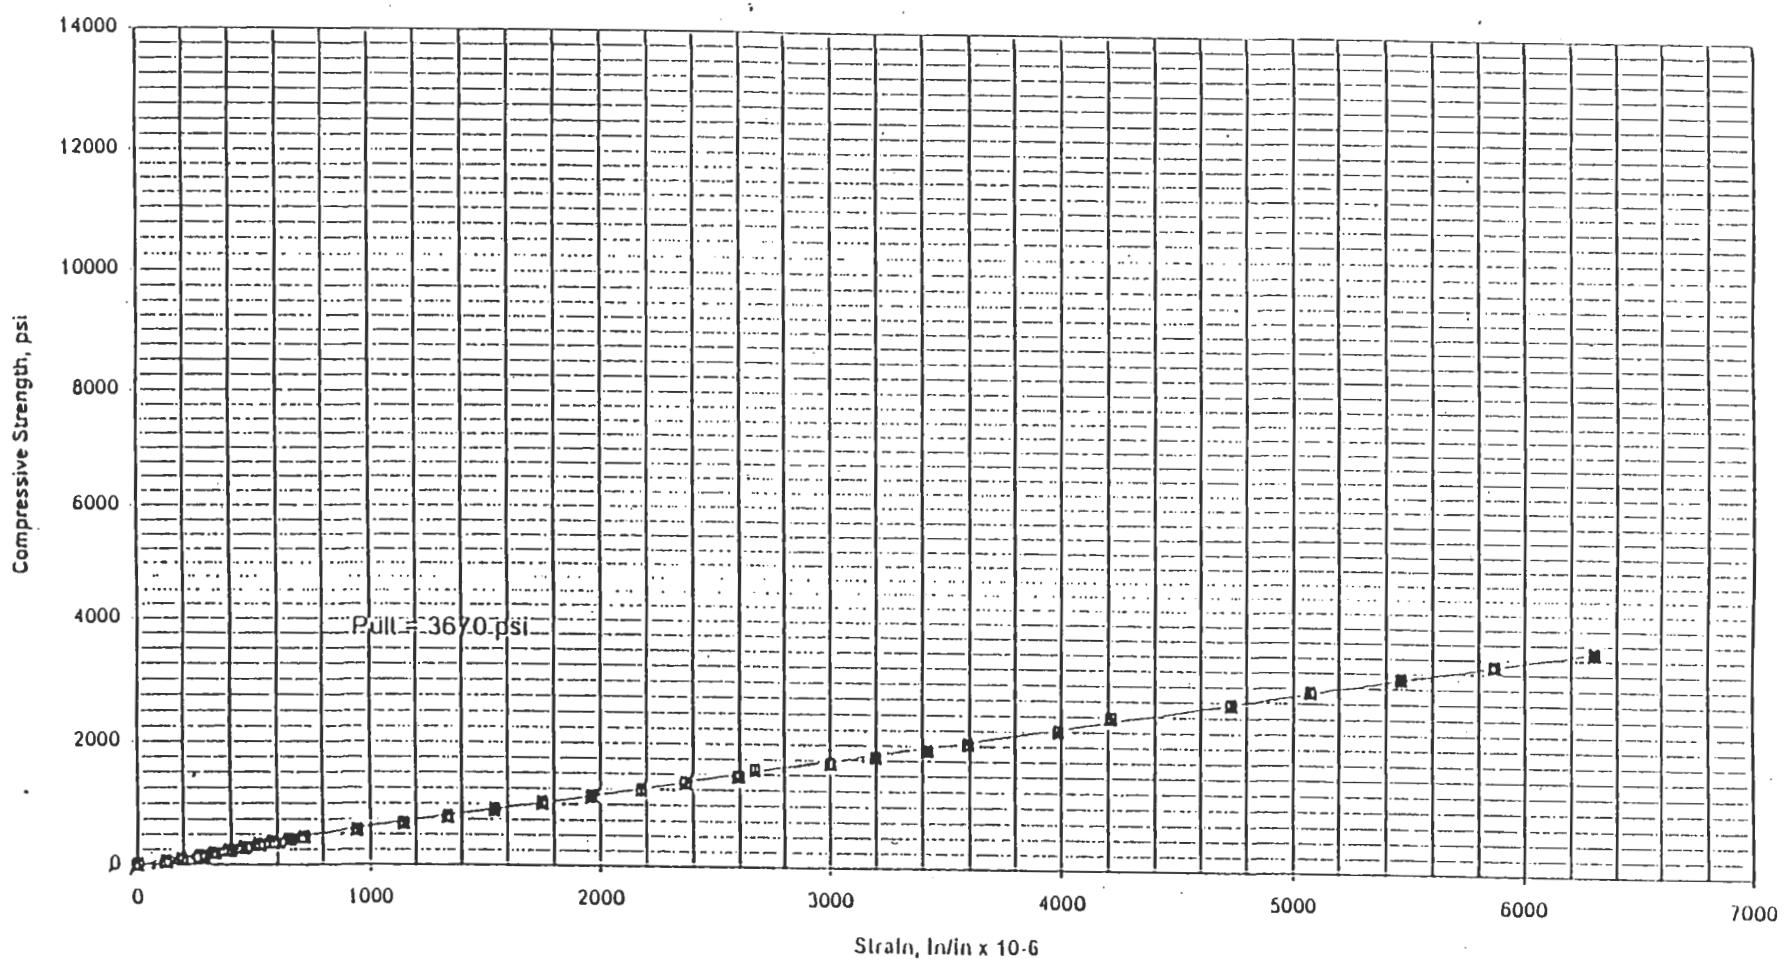
Nominal 2-inch Diameter Rock Core

Drill Hole No. 94-DD-85, Depth 6.5'-6.8'

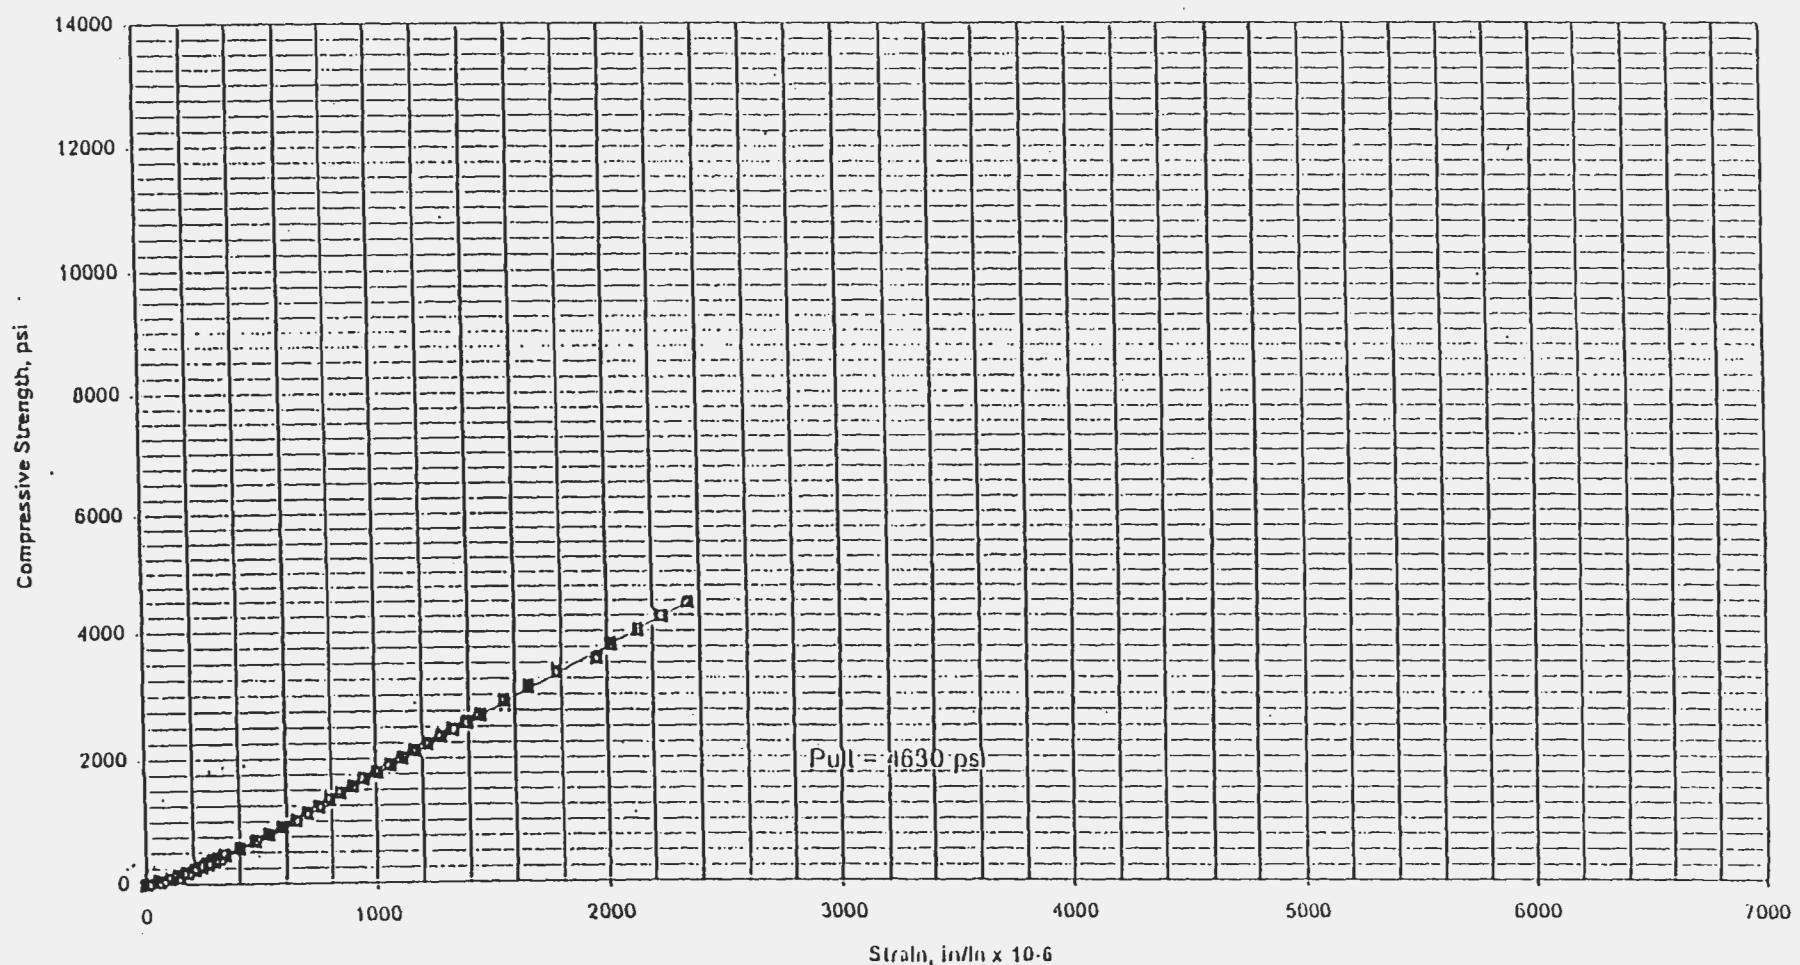
Figure II

Unconfined Compressive Strength versus Strain
Nominal 2-inch Diameter Rock Core
Drill Hole No. 95-DI-95, Depth 13.6'-13.9'

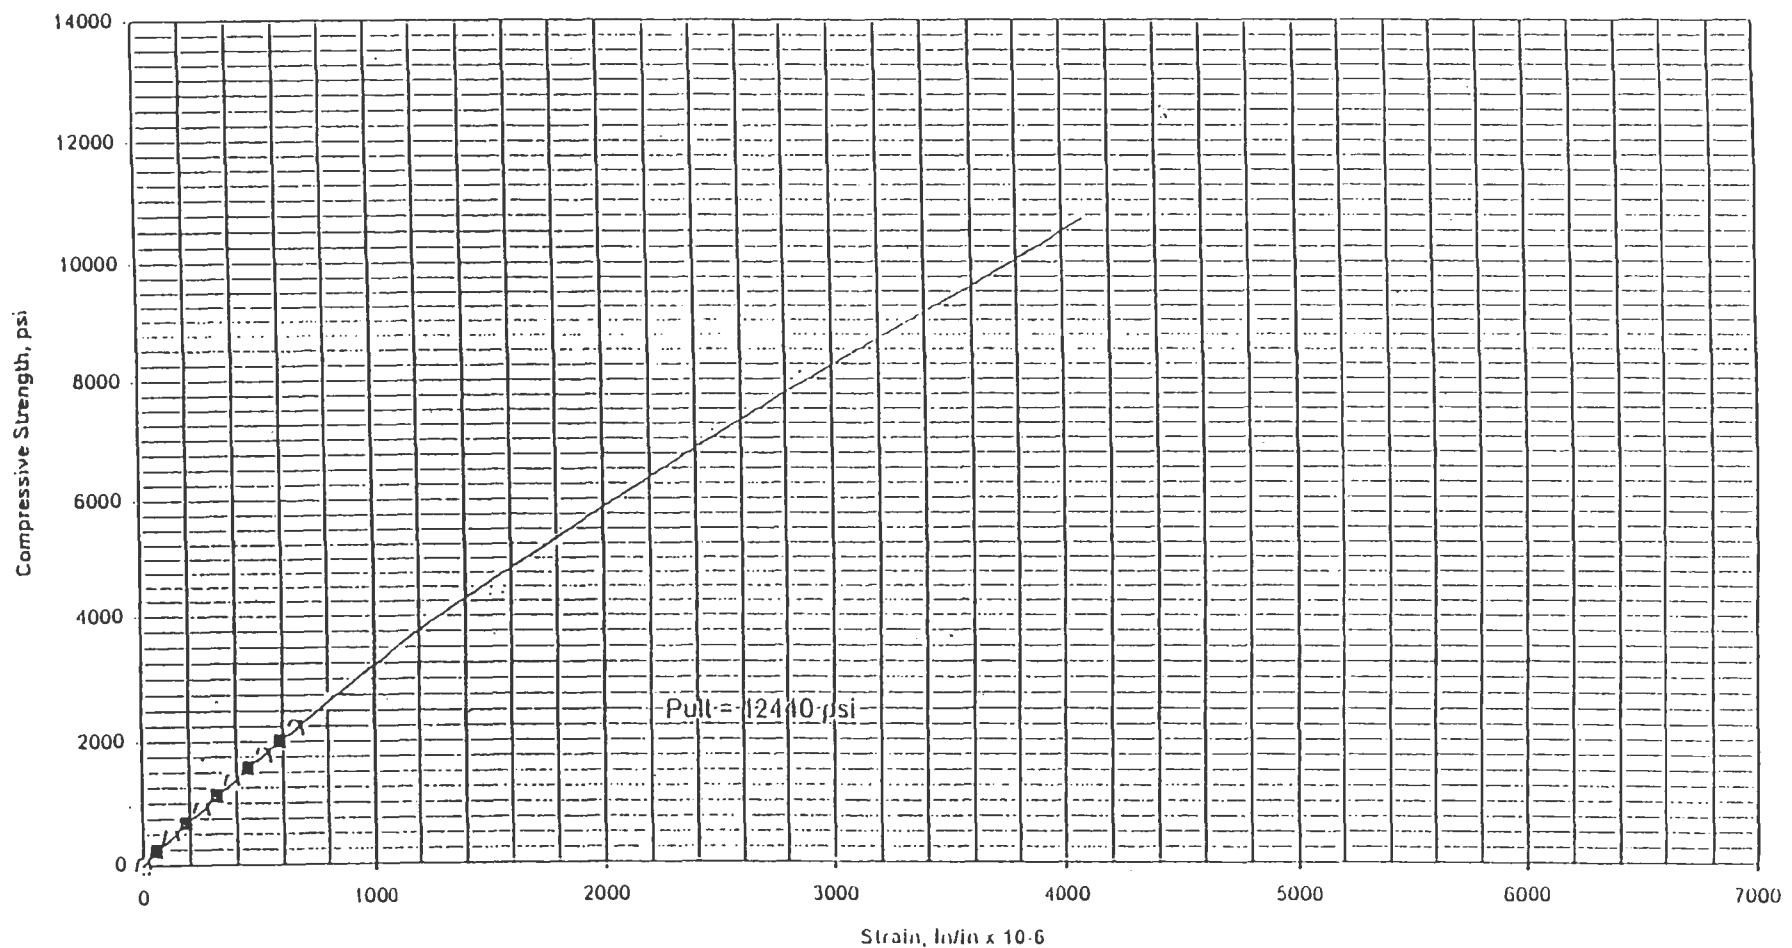
Figure III

Unconfined Compressive Strength versus Strain
Nominal 2-inch Diameter Rock Core
Drill Hole No. 94-DD-85, Depth 24.7'-25.0'

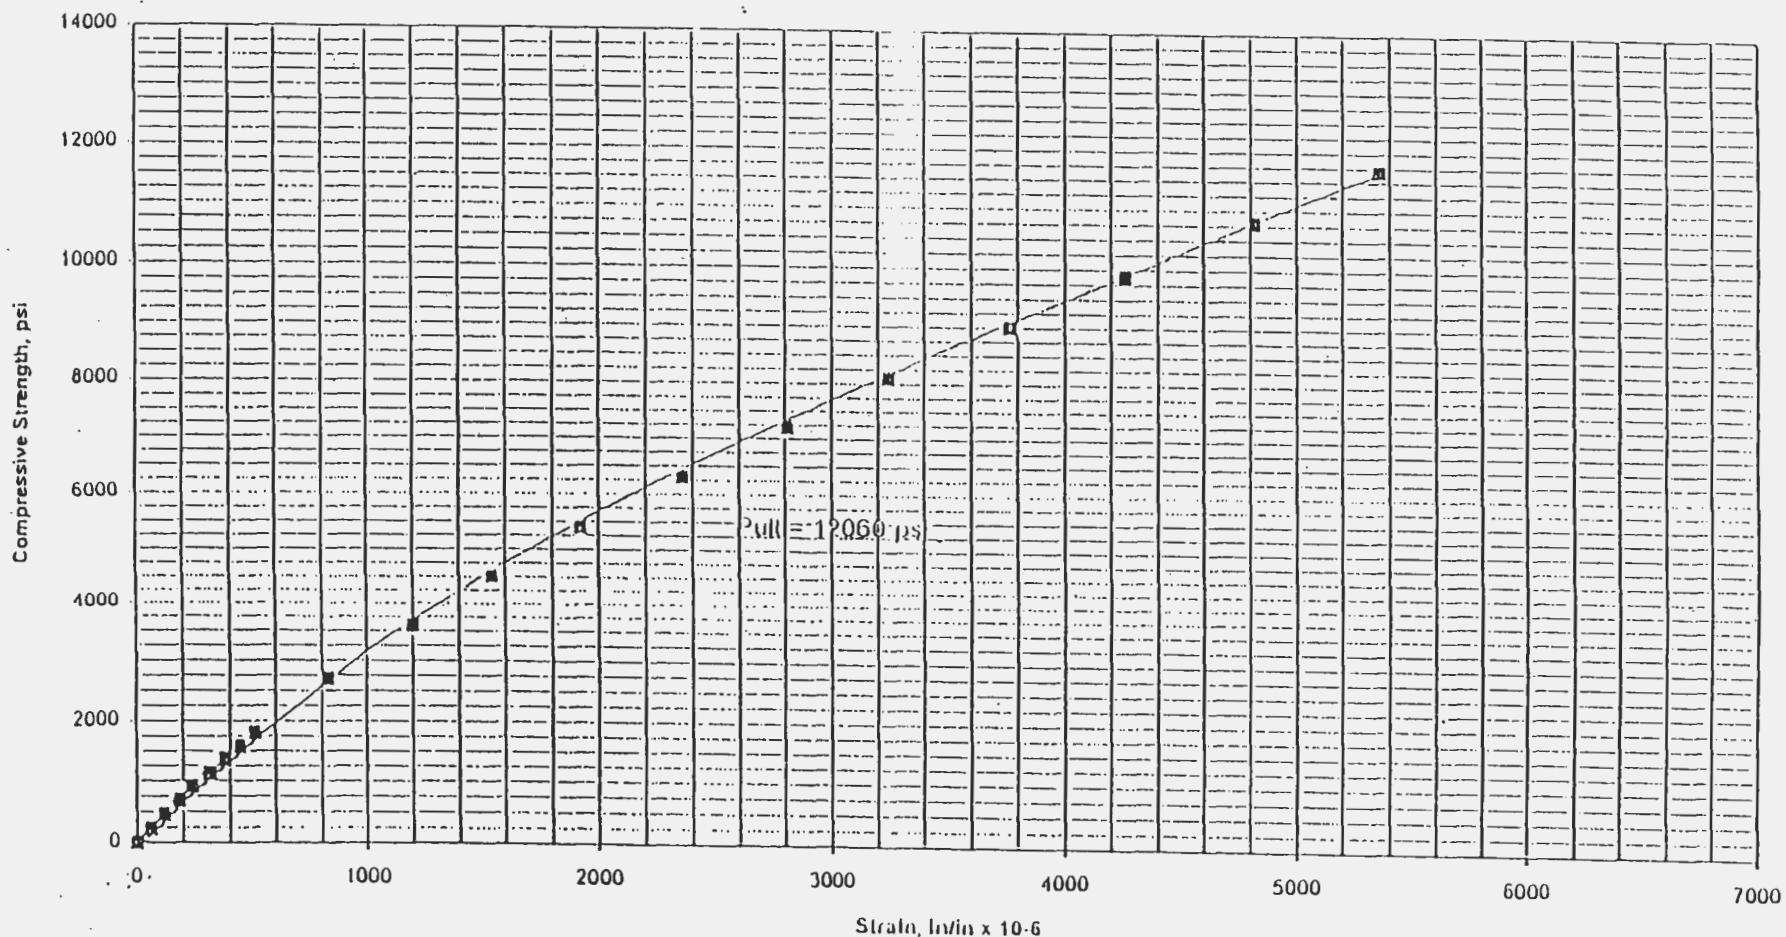
Figure IV

Unconfined Compressive Strength versus Strain
Nominal 2-Inch Diameter Rock Core
Drill Hole No. 95-DD-85, Depth 25.0'-25.3'

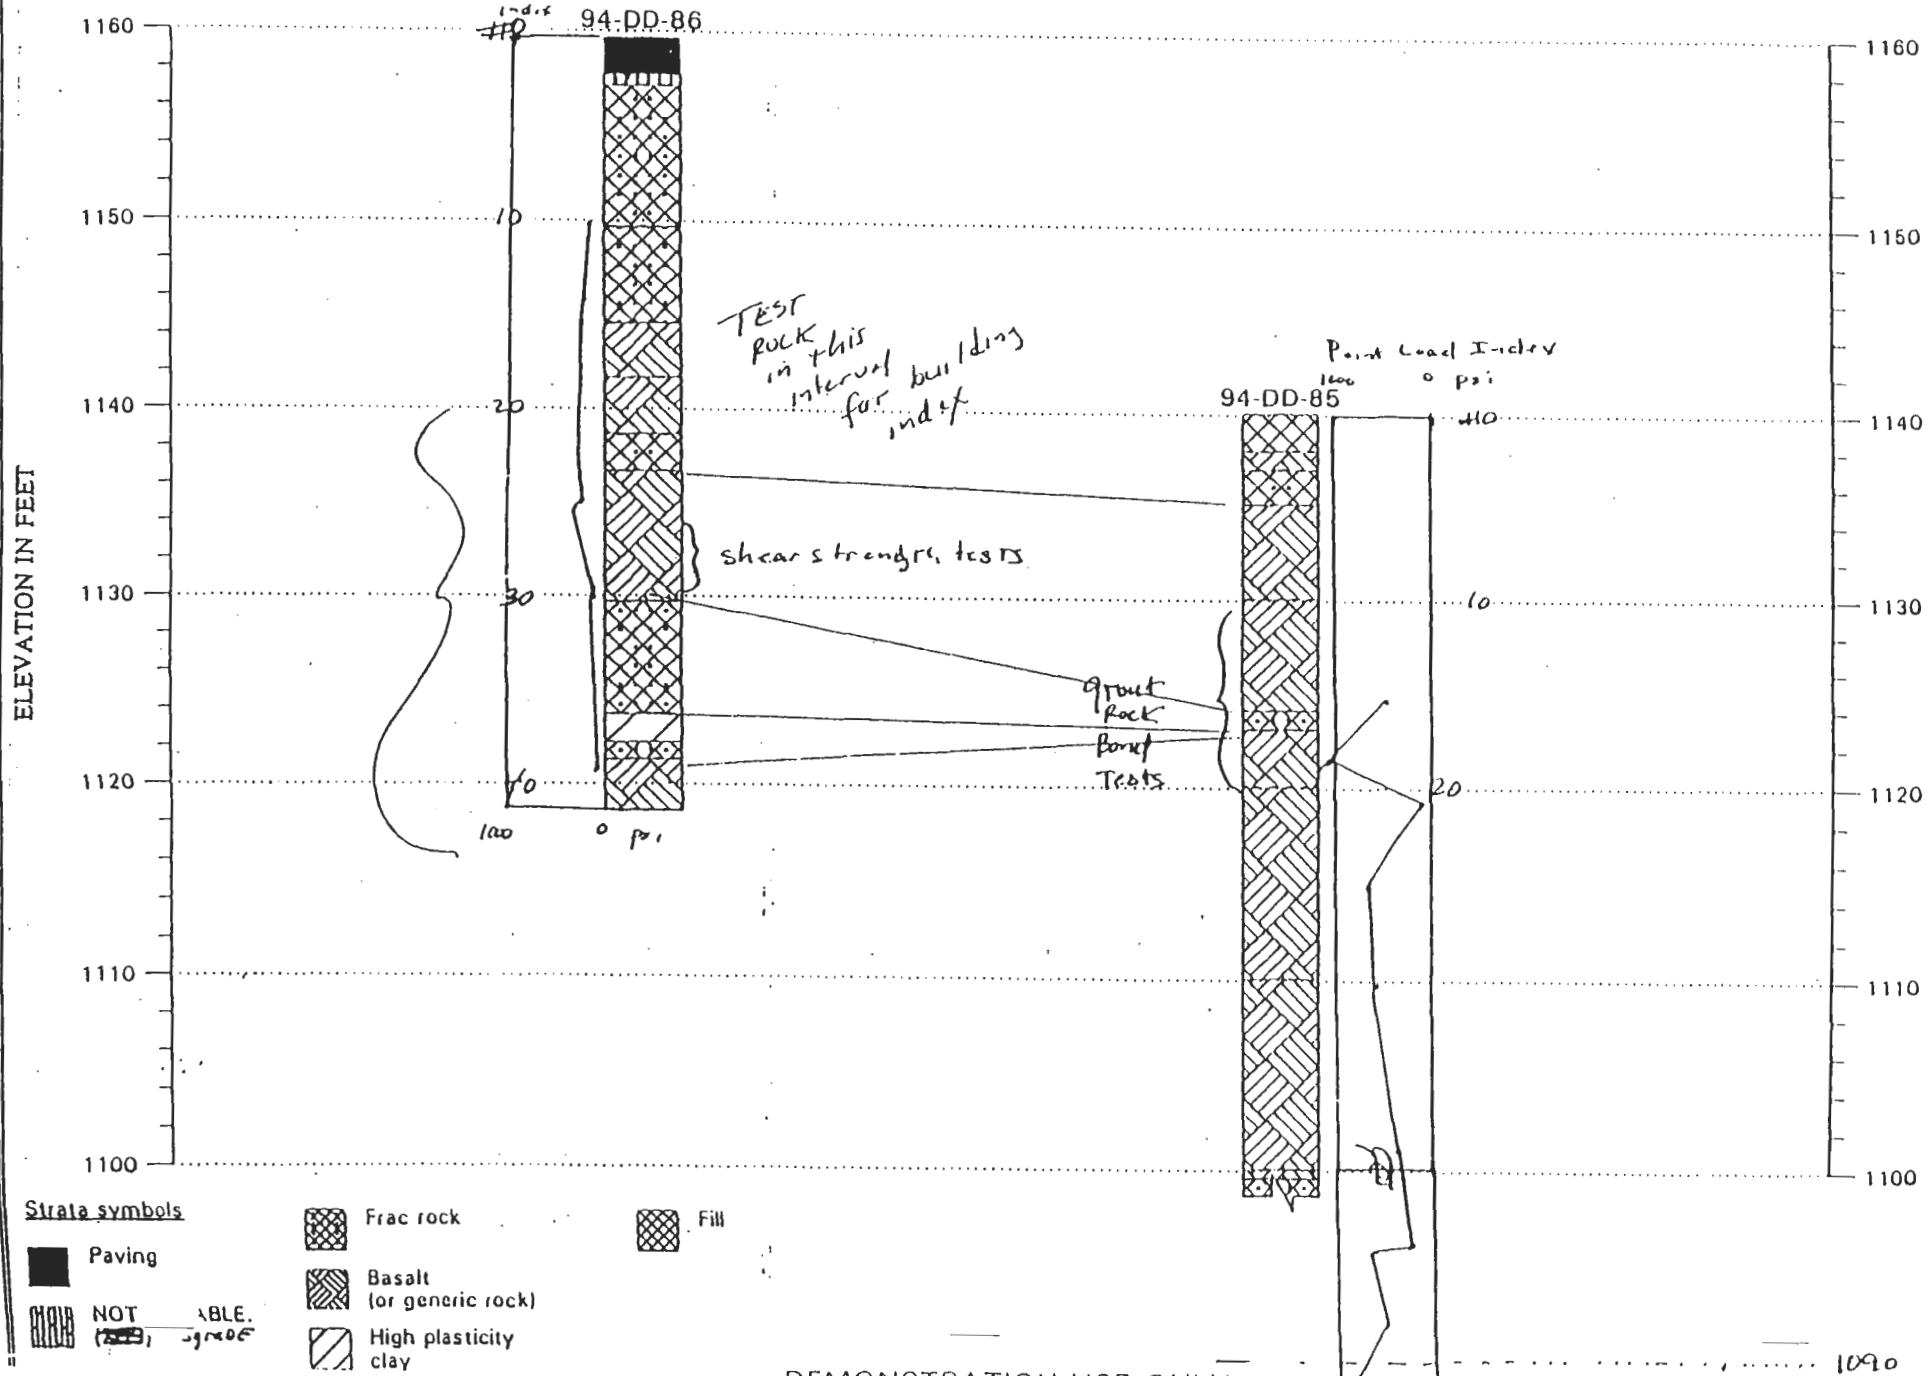
LOG OF BORINGS
HOWARD HANSEN DAM INTAKE TOWER

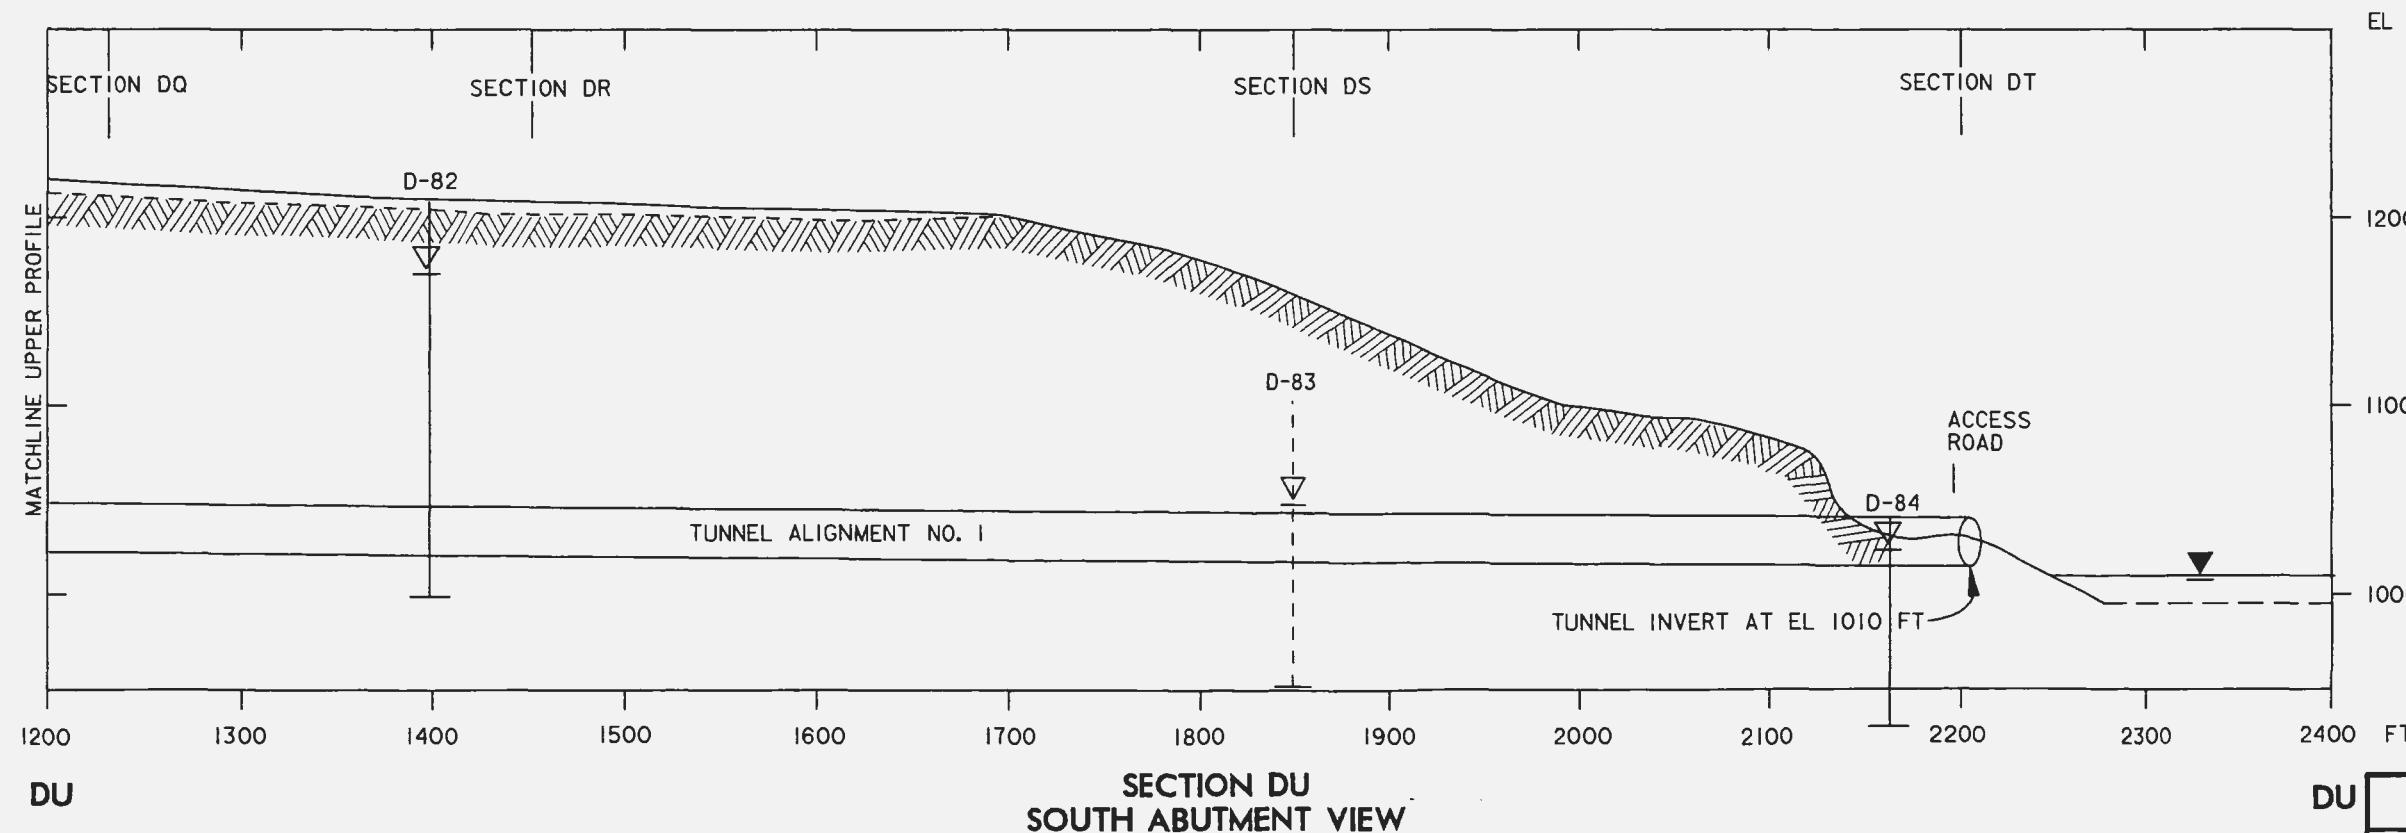
SECTION DU
SOUTH ABUTMENT VIEW

NOTE: ▽ STATIC WATER LEVEL IN BORINGS APR 94

BORING DD-83 IS LOCATED 60' NORTH OF THIS SECTION
AND IS INCLINED 70° FROM HORIZONTAL.

FISH PASSAGE FACILITY HOWARD HANSON DAM
GEOLOGIC SECTION DU TUNNEL ALIGNMENT NO. 1
DSGN: ECKERLIN DATE: 94 NOV 4 EXHIBIT D9
