Memorandum for Record

Subject: Tier 1 Evaluation for the Lower Cherry Creek Restoration Phase II - III, King County, Washington (NWS-2024-926)

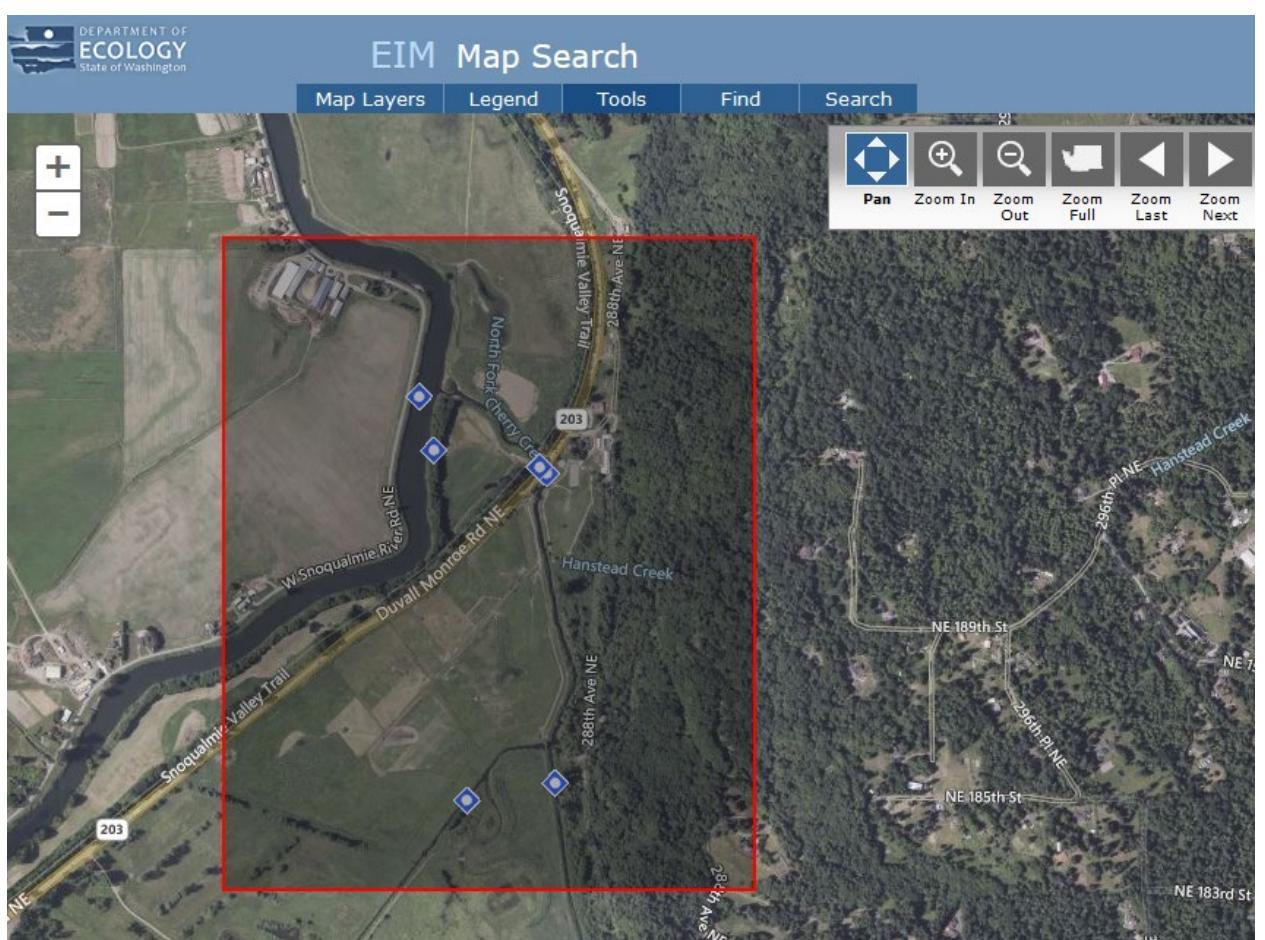
Figure 3: EIM Data Search

*Blue squares represent water quality data near the project site and within the watershed of Cherry Creek.

review chemical or biological data within the vicinity of the project location. No sediment data was available for the site. Water quality samples from near the project site and upstream are seen in Figure 3.
