CENWS-OD-TS-NR

June 5, 2014

**SUBJECT:** DETERMINATION REGARDING THE SUITABILITY OF A **PORTION** OF PROPOSED DREDGED MATERIAL FROM THE MUKILTEO MULTIMODAL PROJECT, MUKILTEO, WASHINGTON, EVALUATED UNDER SECTION 404 OF THE CLEAN WATER ACT FOR UNCONFINED OPEN-WATER DISPOSAL AT THE PORT GARDNER NON-DISPERSIVE DISPOSAL SITE, OR FOR IN-WATER BENEFICIAL USE.

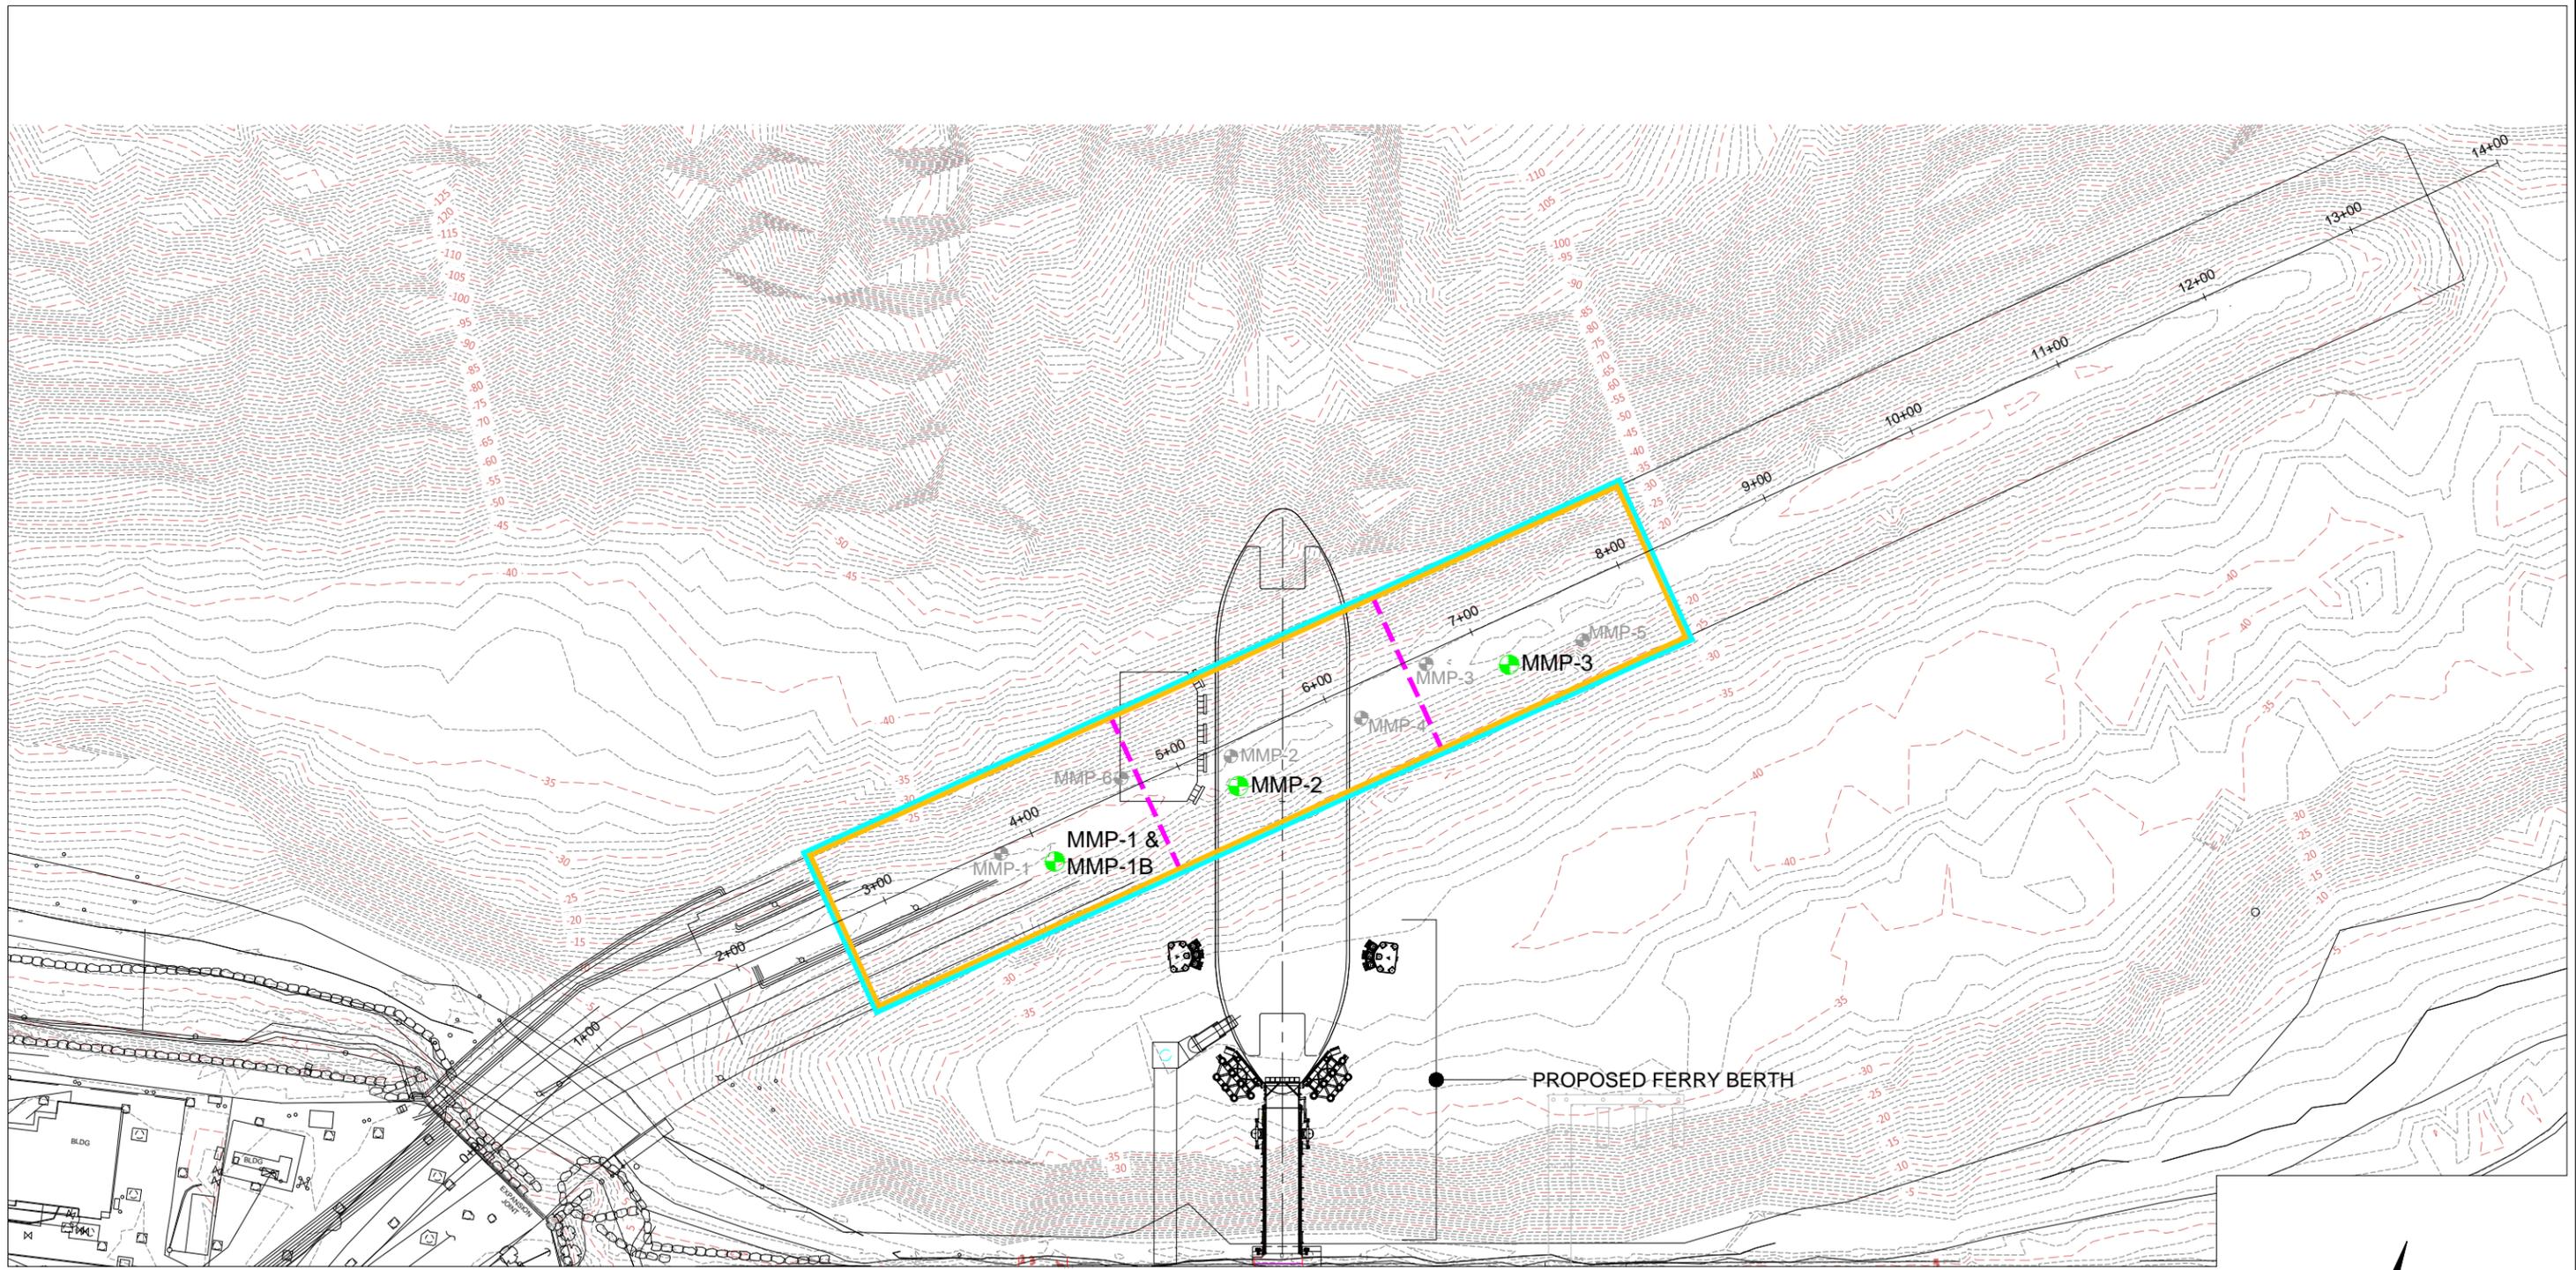
SURFACE DMMU BOUNDARY
-

BOUNDARY OF DREDGE PRISM
-

MMP-1 LOCATION OF NOVEMBER 2013 VIBRACORE
-

MMP-1 PROPOSED VIBRACORE LOCATIONS FROM APPROVED DMMP SAP (2013)

2. **Background.** The Washington State Department of Transportation (WSDOT) Ferries Division proposes the Mukilteo Multimodal Project to improve the operations and facilities serving the mainland terminus of the Mukilteo-Clinton ferry route in Washington State. The project will include a new ferry berth, loading area, waiting area, and associated infrastructure to be located approximately 1,800 feet to the northeast of the existing Mukilteo ferry terminal. The project location is shown on the Vicinity Map and Site Plan (**Figures 1 and 2**).

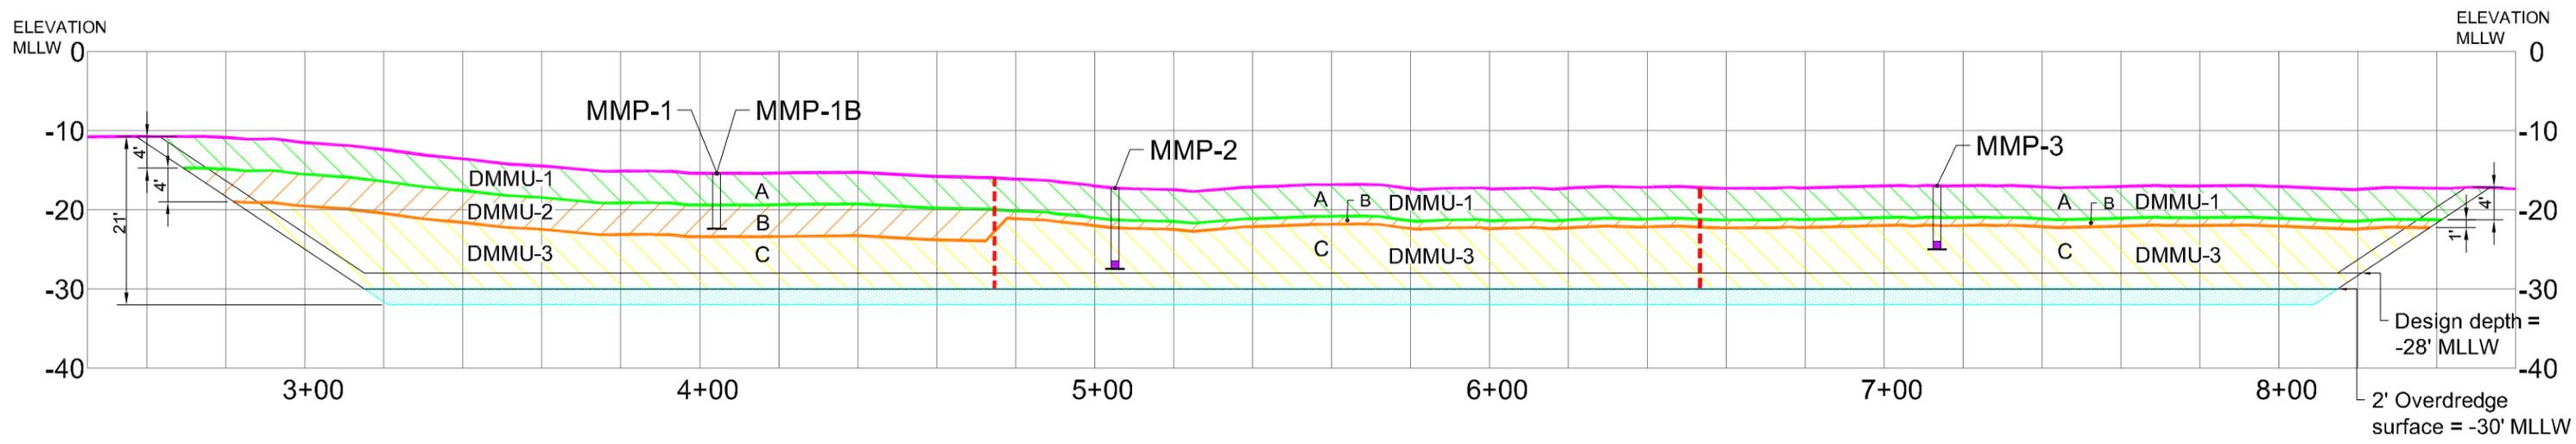
SCALE: HORIZONTAL: 1"=40'  
 VERTICAL: 1"=20'

1. THE LOCATION OF FEATURES SHOWN ARE APPROXIMATE.
2. THIS FIGURE IS FOR INFORMATION PURPOSES AND IS INTENDED TO ASSIST IN SHOWING FEATURES DISCUSSED IN THE ATTACHED DOCUMENT.
3. THE DREDGE PRISM IS ~550 FEET LONG BY ~120 FEET WIDE WITH A DESIGN DEPTH OF -30 FEET MLLW, INCLUDING 2 FEET OF OVERDREDGE.

A new bathymetric survey was completed in January 2014 after draft characterization results were reported to the DMMP (BergerABAM, 2014a). The new bathymetry showed that the mudline of the dredge prism ranged from about -11 to -17 ft MLLW, with an estimated dredge volume of 21,000 cy. This change in bathymetry resulted in a changed thickness to DMMU-3, and showed that Z-layer depths were not achieved at any of the core locations (**Table 3, Figure 3**).
